**Investigation of the truss spans of railway bridge under operating load**

**Abstract:** The paper presents a description of the structure and its damage and a report on study under the operating load of three truss spans of 42.0 m length each. The spans are located in track no. 2 of two tracks railway Chorzów Batory – Tczew. They crosses the Warta River and its flood terrain in Działoszyn. Following spans are located along track no. 2: one steel beam span of 12.0 m, three truss spans of 42.0 m, one truss span of 32.0 m. The spans were built in 1941/42. They are rivet structures with parabolic shape and girders located under railway. A design of bridge repair and strengthening was prepared. Due to lack of funds the repair works were delayed, but all spans were in bad technical condition. Three the longest ones, which had been examined, had low lateral flexibility. Lateral vibration were noticed, which were consider to be dangerous with a speed limit on the bridge  $v \leq 100$  km/h and load class of  $k=+2$ ,  $\alpha_k=1,21$  (according to Polish code). The tests result forced the owner to start repair work immediately (mainly to install lateral stiffeners in all spans to elimi

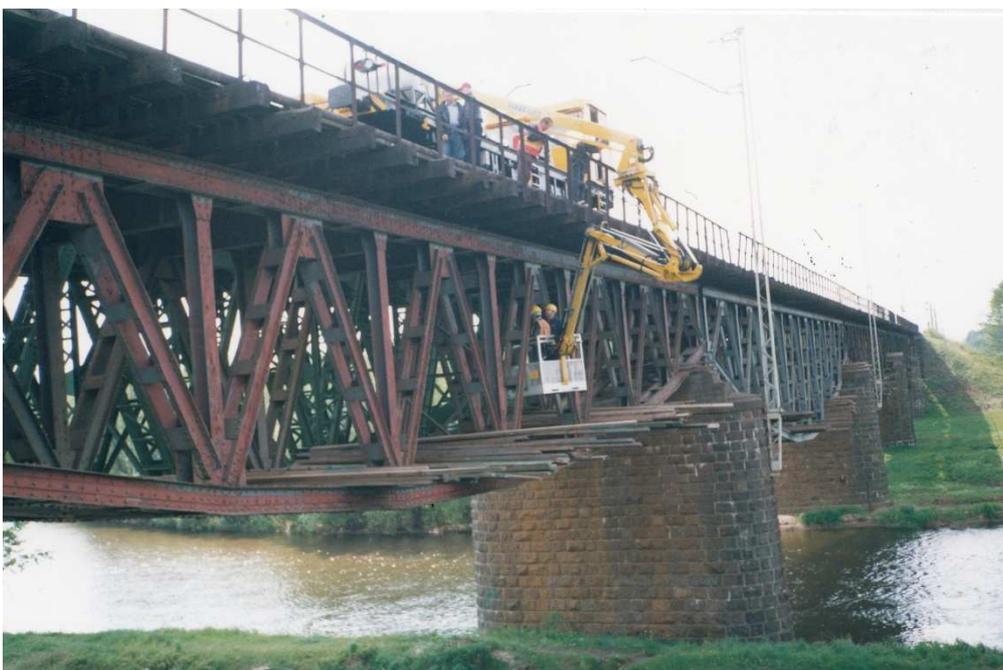
2. Detailed review of truss girders of the bridge spans

During the previous periodic inspections of this object, numerous damage was found to qualify spans and supports for the main repair in both tracks on the bridge. According to Instruction Id-2 [2] and Id-16 [3], a detailed inspection of the bridge in track No. 2 was also carried out (Fig. 2). As a result of the inspection of the spans, bearings and bridge supports, also using the diagnostic draisine of the Zakład Mostowy Kędzierzyn-Koźle, numerous damages were found, mainly within steel spans. Additionally, during the use of the spans in track no. 2, it was revealed that lattice bays no. 2, 3 and 4 suffer noticeable horizontal transversal displacements (vibrations). This phenomenon intensified during the passage of heavy freight trains. Initially, it was thought that this was due to inaccuracies on the support of the spans, mainly after widening the space to 4.0 m. However, after adjusting bearings and repairing underarms, the phenomenon did not diminish, and as a result of subsequent inspections of the spans, cracks in gusset plates were found at the connections of the upper girders lattice with cross-bars and upper wind braces and extensive pitting and surface corrosion of these elements. A certain difficulty in accurately assessing the effects of damage and developing project documentation was the lack of archival drawings of all spans, which required supplementary inventory measurements.

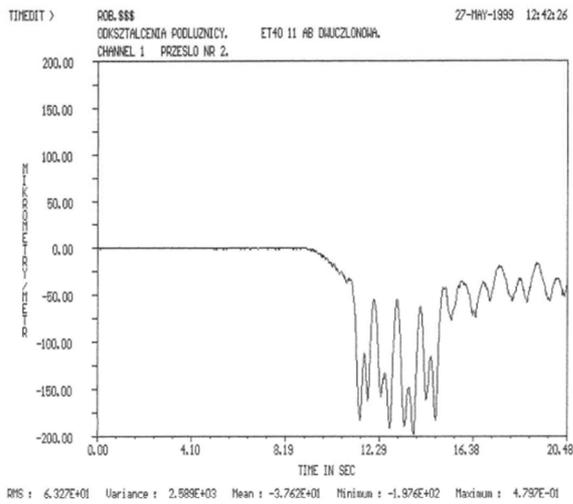
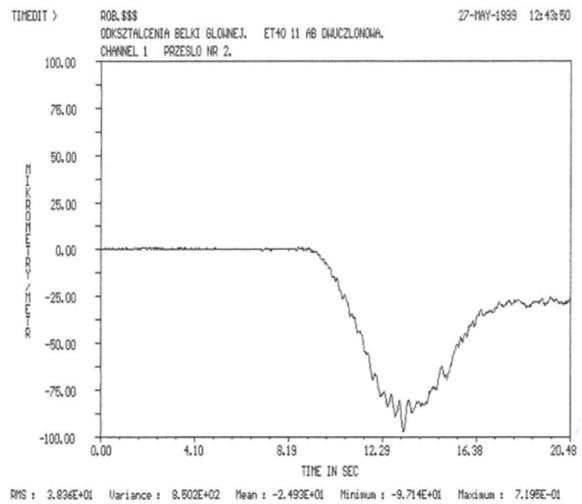
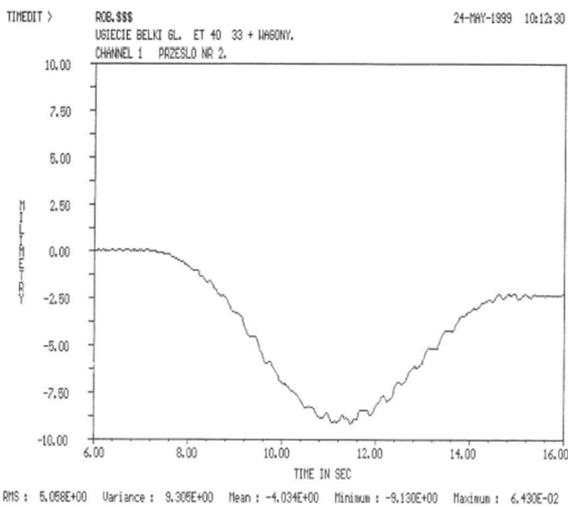
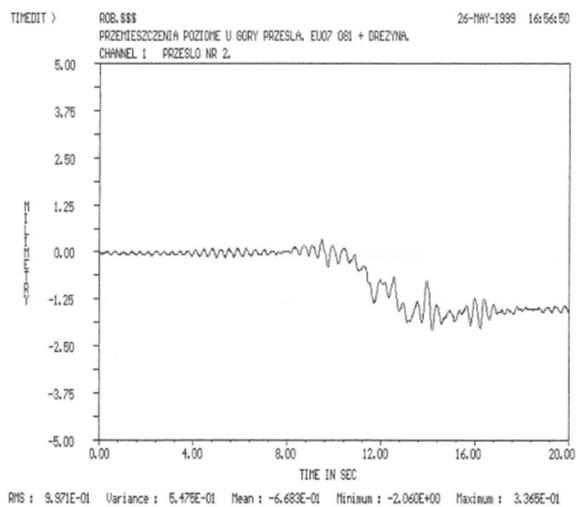
a) Przęsło nr 2

- time courses of unit deformation oscillations in the stringers are very complex, one can notice a significant impact of the dynamic factor; the maximum recorded stress from the operational load occurred in the longitudinal member in span No. 4 and amounted to  $\sigma_d = 60,04 \text{ MPa}$ , the extreme effect of the dynamic factor occurred in the longitudinal member in span no. 3 and amounted  $\varphi_3 = 1,774$  with the dynamics share 43,6%,

- oscillations of unit deformations in the upper stripe of the main beam are of quasi-static character with the dominance of statics; maximum stresses occurred in span No. 4 and amounted  $\sigma_d = 26,06 \text{ MPa}$ , and the maximum dynamic coefficient is  $\varphi_3 = 1,154$  (span No. 3 with dynamics share 13,37%),

- vertical displacements (deflections) in the main beam from operational loads have a complex quasi-static nature; the maximum value of the dynamic coefficient is  $\varphi_4 = 1,049$  (dynamics share 4,70%) and the biggest deflections are  $q_d = 10,81 \text{ mm}$  (span No. 4). Purely dynamic frequencies range from  $f=2,046 \text{ Hz}$  (span No. 2) to  $f=7,00 \text{ Hz}$  (span No. 4),

- horizontal oscillations are very complex, with a very significant influence of dynamic factor; maximum deflections of the main girder occurred in span No. 4:  $q_d= 4011 \mu\text{m}$  (top of span in  $\frac{1}{2} l$ ),  $q_d= 4141 \mu\text{m}$  (bottom of span in  $\frac{1}{2} l$ ) where the share of the dynamic factor itself is  $749 \mu\text{m}$ , which gives as much as 18.1% and  $q_d= 3120 \mu\text{m}$  (top of the span on the support in span No. 4).
