Instytut Kolejnictwa

DOI: 10.35117/A\_ENG\_18\_05\_02

**Study of lateral wear of needles in railway switches**

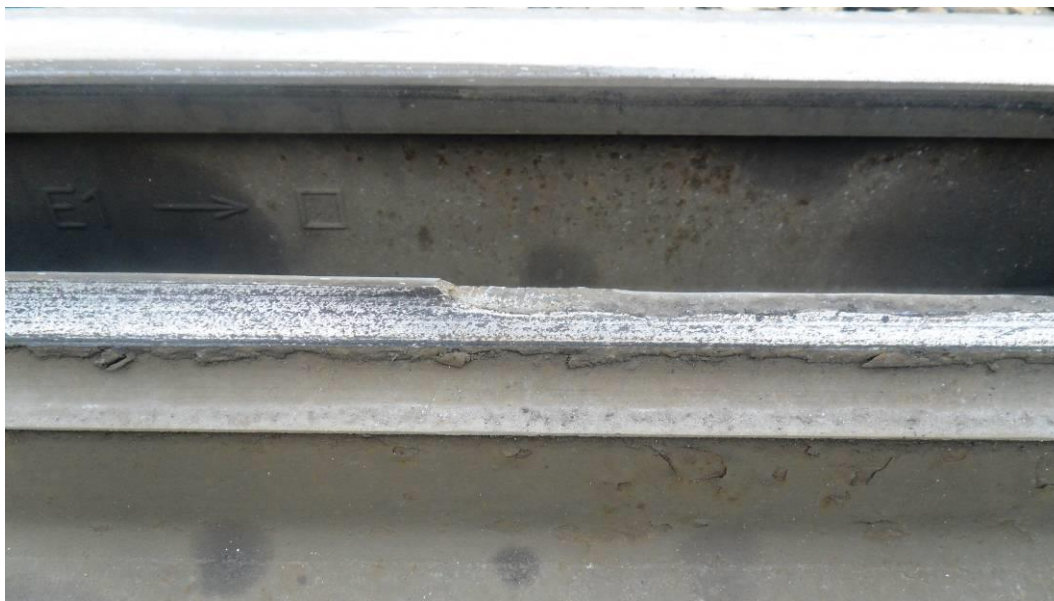
1. The chipping of the worn needle

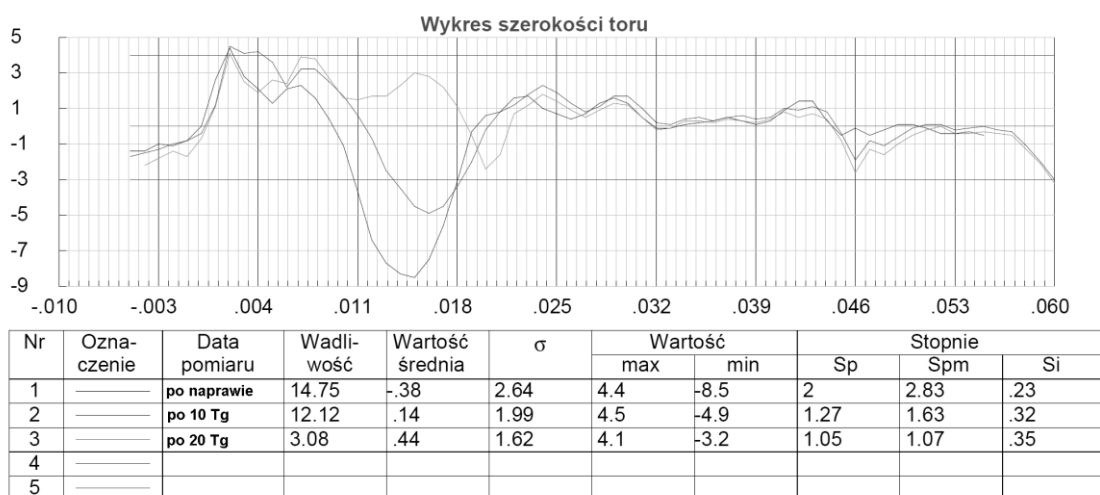
2. The graph of the straight track width in the switch

Figure 1 shows the superimposed diagrams from the measurement of straight track in the switch, made after installation and after 10 and 20 Tg. Visible narrowing of the track at the beginning of the operation (more than 8 mm in value) is visible, which can affect the excessive lateral wear of the needles. In the case of measurements with a traditional torch of

this type, the fault may be overlooked. Narrowing of this value may result from inaccuracies in the assembly of the turnout before installation (which also occurs on prestressed concrete sleepers [3]) or is caused by the deformation of the needles, e.g. due to improperly adjusted under-pile rolls. Another parameter that may have an impact on excessive wear are increased values of cant and twist, as a result of which there may be an uneven load on the rail tracks, including the load on the external course affecting the increased wear of the needles and rails. As with the track gauge parameter, it is also recommended to measure the twist and cantilever using a self-recording torch.

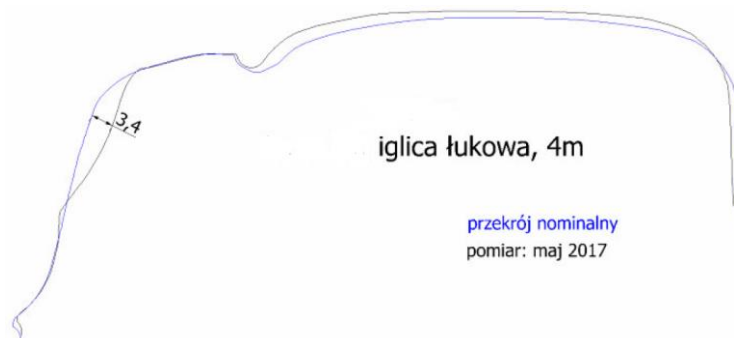
### **5. Wear of the arc needle**

The switch, in which the largest lateral wear in the arched needles (3.4 mm) was recorded, was a switch built in the main track (Figure 5). In the turning direction of the turnout, the entire freight train traffic took place at the station, as it led to a group of freight tracks. It was estimated that the cumulative load accumulated in the turning direction of this turnout was about 20 Tg. Experience from other measurements indicates that at this load value, the lateral wear of arc needles (R260 grade steel) of 4 mm is not an anomaly. When using such a value, there are often nicks in the spikes (Figure 1). The measurement of hardness of the arched needle was also carried out in the switch; the values were over 260 HB.

The tests showed a clear relationship between the lateral wear and the value of the hardness of the needles. The use of cured steel needles should therefore be considered highly justified. The aim of alleviating the effects of the wear phenomenon is also required to grind turnouts both in the initial mode, thanks to which the occurrence of defects is limited [1], as well as in the preventive mode to remove runoffs. In recent years, many solutions have been implemented on the Polish rail network, which are conducive to reducing the occurrence of lateral wear of the needles. These include the widespread use of track lubricators, as well as an increase in the number of turnouts with needles made of hardened steel, or the improvement of the geometric quality of switches by deliveries in blocks.
