Instytut Techniczny Wojsk Lotniczych

**Selected issues of materials testing of rolling bearings adapted to work in elevated temperatures**

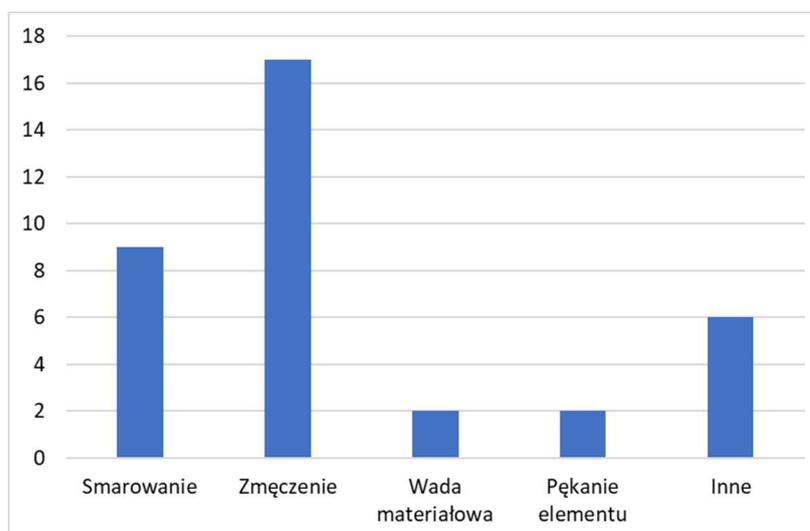
Fig. 1 presents a list of the number of bearings tested depending on the type of bearing damage, in which the following damage was distinguished: incorrect lubrication of the bearings, fatigue running off the treadmill, material defects in the form of too large carbides, cracking of bearing construction elements and others. In the last category, cases of bearing

damage as a result of excessive action of longitudinal loads, excessive clearance in bearings and excessive loads, faulty bearing performance, electric arcs between the outer ring and the injector were presented [5]. The most common causes of bearing damage were fatigue running off the treadmill (47%) and incorrect lubrication of the bearings (25%).

1. List of causes of damage to rolling bearings of a light helicopter compressor turbine, (based on the archive of the Institute of Aviation Material Engineering, ITWL)

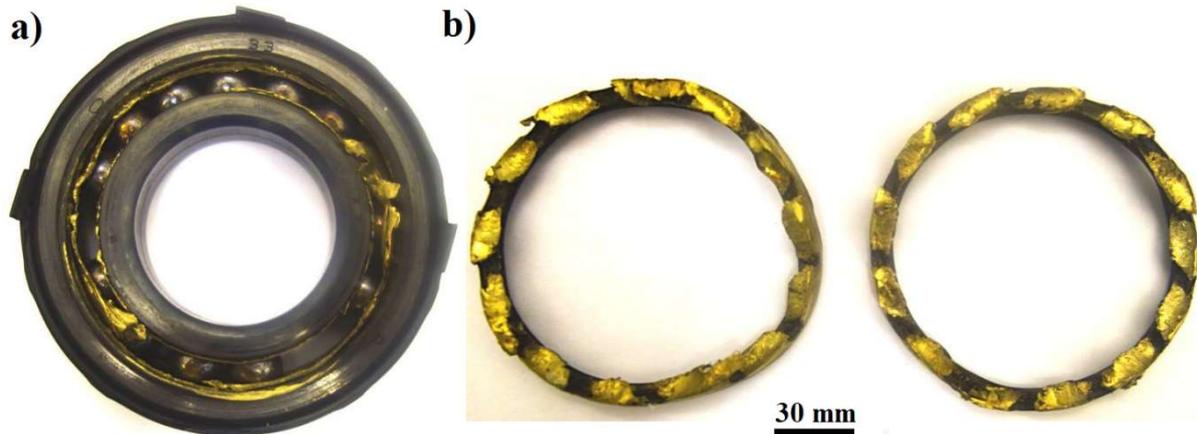
Both objects tested were single row deep groove ball bearings with a divided internal race. Their damage consisted of breaking the separators into two parts (cracking occurred in the thinnest places of the balls' nests) and their significant plastic deformation with the traces of tearing the balls onto the sockets. The treadmills and balls were covered with a layer of foreign material, the non-working surfaces were oxidized. An example of a delivered bearing (bearing B) for tests is shown in Fig. 2. The bearing B is supplied together with the damping sleeve applied to it, while in the case of the bearing A the damping sleeve is not provided.

**2. Bearing B in test delivery condition:**  
a) outer ring, internal half-washers, balls, silencer; b) separator

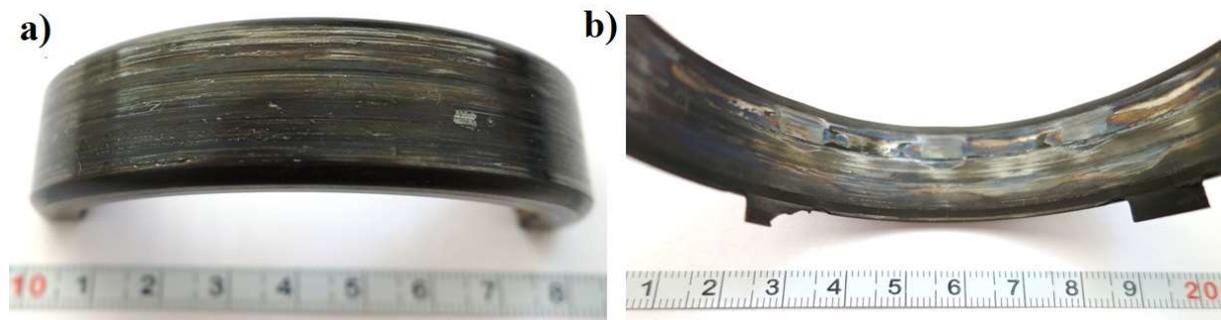
Despite the quite similar type of damage, both bearings show clear differences. The bearing B was rotated in relation to the damping sleeve after locking, as evidenced by the circumferential cracks on the external surface of the outer ring (Fig. 3a) and peripheral cracks and thermal discolorations on the inner surface of the damping sleeve (Fig. 3b). Such traces were not found in bearing A.

**3. a) Outer surface of the outer bearing ring B;**  
b) the inner surface of the vibration damping sleeve

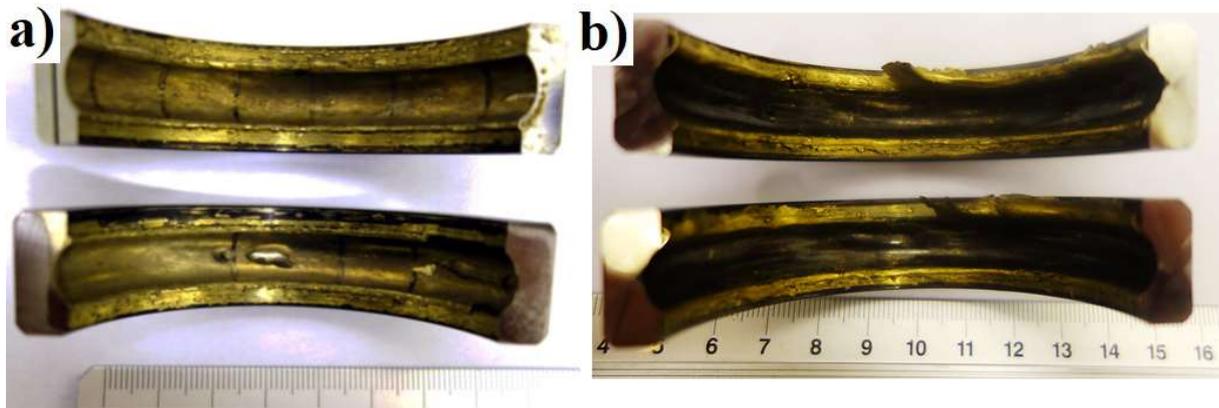
Another difference is the appearance of the foreign material layer, which was applied to external treadmills (Fig. 4) and internal treadmills (Fig. 5). In the case of bearing A (Fig. 4a, 5a), the foreign material layer has a dark yellow hue, is rough and contains discontinuities revealing the tread surfaces locally. In addition, on the outer treadmill (Figure 4a), the protrusions on the foreign material layer are distributed at regular intervals corresponding to the arrangement of the balls. The layer of foreign material applied to the bearing track B (Fig. 4b, 5b) is smoother, with no discontinuities, has a non-uniform color: in places, it is dark yellow, sometimes dark gray. The inner half-washers were connected through it (Fig. 5b). At the tread edge, it creates larger flashings compared to those observed in bearing A.

4. Outer rings after cutting: a) bearings A; b) bearings B

The layer of foreign material was also applied to the surfaces of outer rings adjacent to the outer centering surfaces of the separators (Figure 4). In both cases, its appearance is similar: it has a pale yellow color with visible flattened lumps of the same color. This shows together with the circumferential features on the outer surfaces centering the rubbing of the separators when the bearing is in operation with the outer rings (fig. 6). Fragments of the bearing separator B are assessed as more deformed than the bearing A due to the more pronounced bending of the separator rings and the flattening of damaged balls' nests.

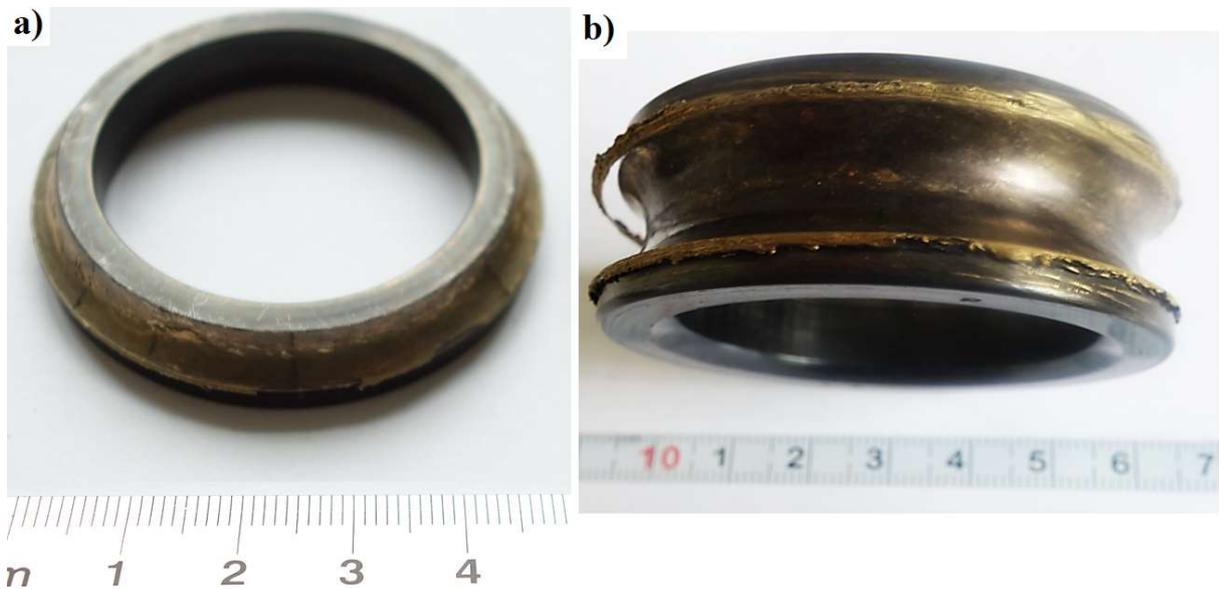
5. a) One of the inner rings of the bearing A;  
b) the inner half-rings of the bearing B connected

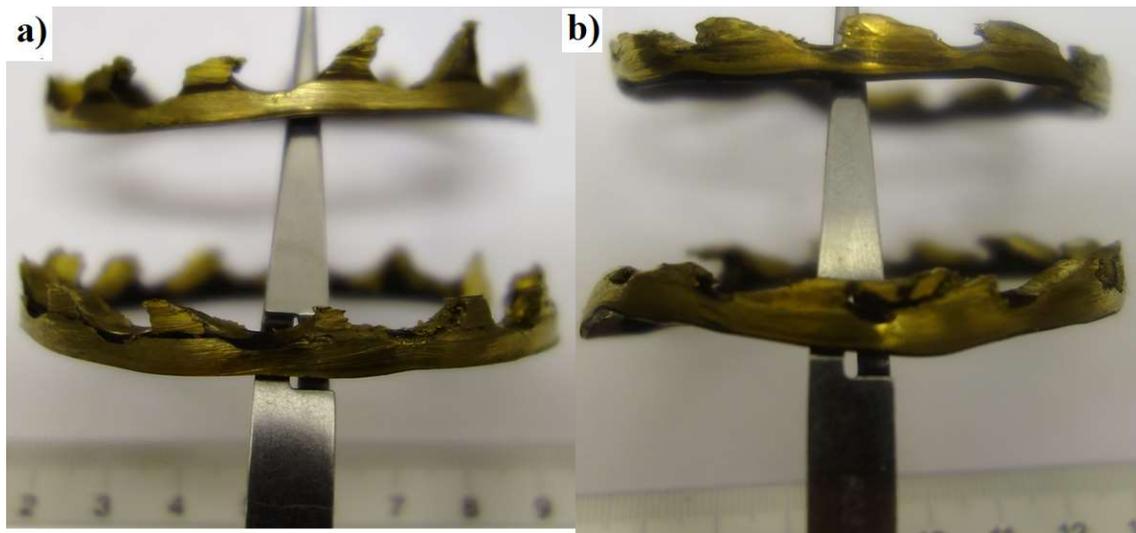
6. The outer centering surface of the separator: a) bearings A; b) bearings B

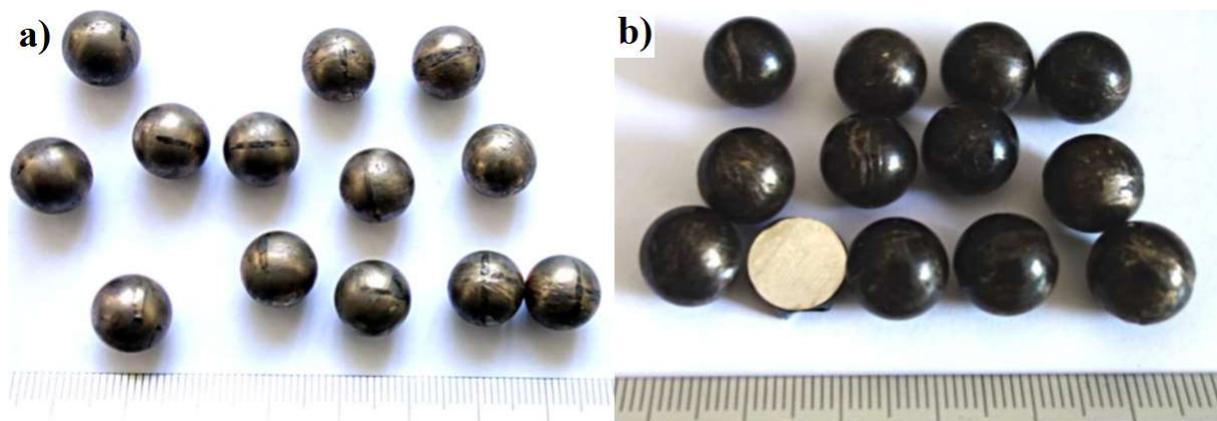
The balls of both bearings (Fig. 7) have a different surface appearance - the balls from bearing A are covered with a dark-yellow foreign material similar to that observed in the treadmill, longitudinal beads of foreign material are visible after breaking the balls from the treadmill, cracks are visible ( Fig. 7b), while in the case of balls from bearing B the surface is dark with numerous traces of abrasions (Fig. 7d).

7. a) Bearing balls A; b) the surface of one of the bearing beads A;  
c) Bearing balls (one of the balls has been cut)

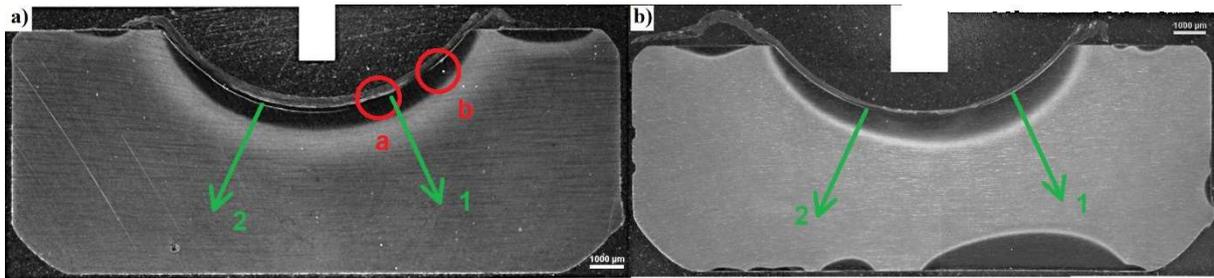
On macroscopic photographs of the cutouts of the cross-sections of the outer rings of both bearings (Figure 8), thermal degradation zones (SDC) are visible which manifest themselves in a different method of grinding and a layer of foreign material. In the case of the outer ring of the bearing A (Fig. 8a), the SDC is observed in the entire region of the treadmill and at the edges adjacent to the separator. The sample of the outer bearing ring B shows a greater number of SDCs: on one of the faces and on the outer surface, which is related to the rotation of the outer ring relative to the damping sleeve. It should be noted that the observed SDC, especially in the area of the raceway, are not symmetrical, especially in the case of the outer ring of the bearing B. This may be related to the place of application of the maximum radial forces.

**8.** Macroscopic photo of a nitral-cut grinding of a metallographic cross-section of an outer ring with marking of further observation points and hardness measurements:  
a) bearings A; b) bearings B

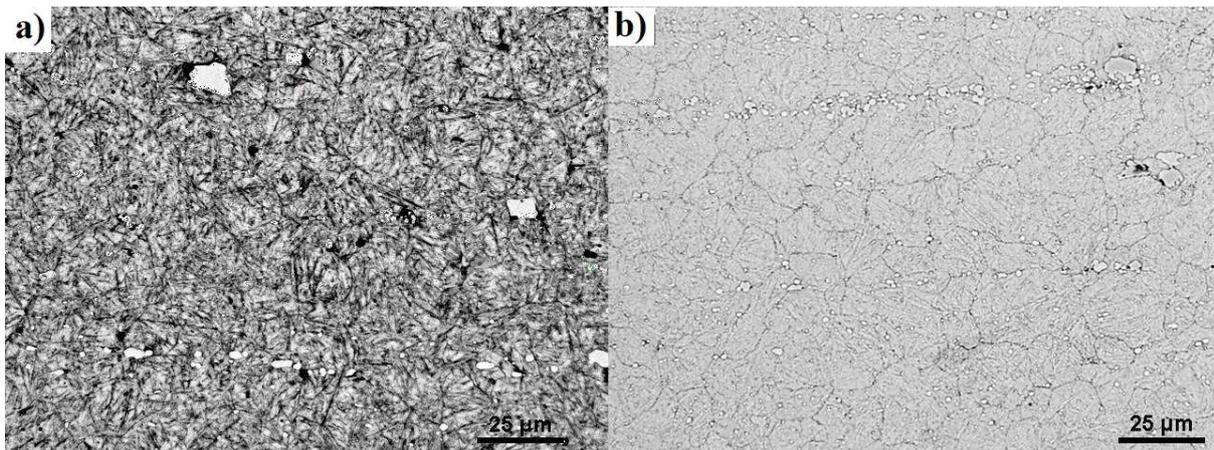
The correct microstructure of the steel parts of the bearing is shown on the example of the outer ring of the bearing A (Fig. 9a), which is tempered martensite with carbides. The measured hardness is  $789 \pm 11$  HV10, while the required hardness is 694-809 HV10. The microstructure in the surface area of the thermal degradation zone is shown in Fig. 9b, it is undissolved martensite with carbide precipitates. Such a structure is created by heating the steel to the austenitizing temperature (900-1000 °C in the case of Cr-W-V alloy steels) and sufficiently fast cooling. The example hardness measured in such a zone is 769 HV1 (Fig. 9b).

**9.** a) Microstructure of the core of the outer ring sample - normal microstructure, hardness 789 HV10, b) microstructure at the surface of the thermal degradation site - microstructure after secondary hardening, hardness 769 HV1

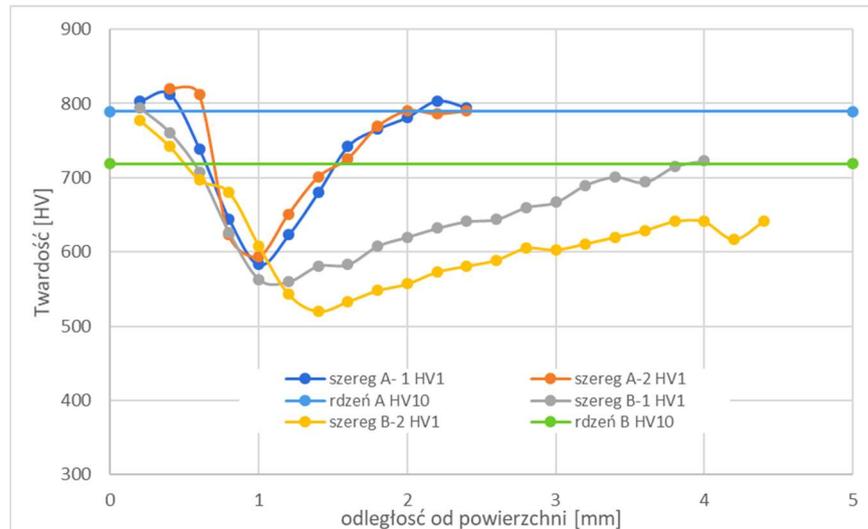
The SDC depth was estimated using linear hardness distributions (Fig. 10), behind which the distance from the cross-sectional edge was taken to the place where the material reached the hardness in the core. The measured hardnesses at the cross-sectional edge in the SDC usually have a hardness close to or greater than the hardness of the material in the core, which as mentioned above is related to the subsequent quenching of the material. The gradual lowering of the temperature causes the tempering process to take place, i.e. the formation and growth of carbides. The minimum drop in hardness is observed at 700-800 °C.

On the basis of the obtained results, it can be stated that the SDC depth measured in the outer ring of the bearing at similar measuring points is significantly higher compared to bearing A. In the place of series 1 the material does not achieve core hardness due to the proximity of another SDC (Fig. 8b). In place of series 2 about twice as large SDCs were obtained. The hardness measured in the core of the outer bearing B ring ( $718 \pm 16$  HV10) is smaller compared to bearing A (789 HV10) due to the larger thermal-degraded area.

**10.** Diagram of dependence of hardness on the distance from the surface of the outer ring of bearings A and B, taking into account the hardness measured in the core of the samples

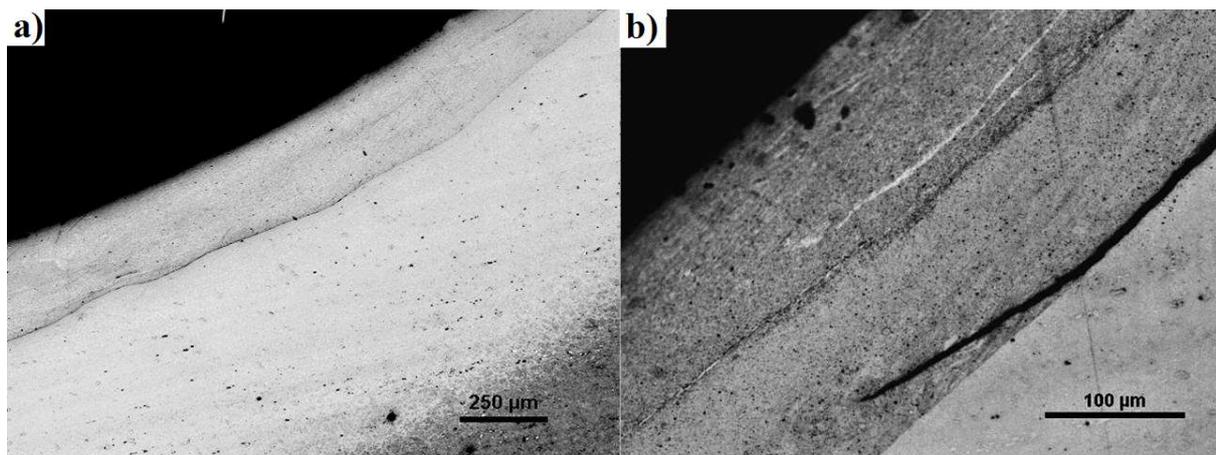
Fig. 11 shows the microstructure of the foreign material layer applied to the external race of bearing A in four places as indicated in Fig. 8a. This layer differs in construction depending on the place of occurrence. In place of the largest balls pressure on the outer treadmill (Figure 11a), the foreign material layer adheres closely to the ground. It is composed of two sublayers - chemical composition tests have shown that the lower sublayer consists of chemical elements of the bearing steel (iron, chromium, tungsten, vanadium), while the upper sublayer consists of a mixture of elements both in the chemical composition of the bearing steel and separator material (copper, aluminum, nickel, iron, chrome, tungsten, vanadium). The boundary between the sub-layers is hardly visible. In the area of "b", the separation boundary is more visible, the upper sublayer contains pores and thin inclusions with a bright shade. Delamination is also characteristic. Both sublayers coexist along the entire periphery of the treadmill. The thickness of the layer is between 213-342  $\mu\text{m}$ . The layer has a minimum thickness in the area of close adhesion (no delamination).

**11.** The microstructure of the areas at the bearing outer race A on the basis of Fig. 10a:  
 a) the center of the treadmill; b) the rest of the treadmill

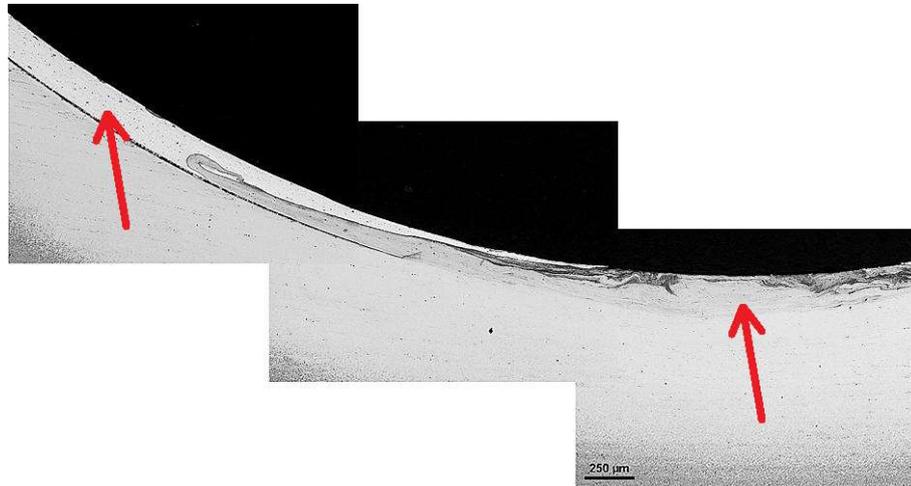
The layer of foreign material applied to the outer race of bearing B (fig. 12) is significantly different to bearing A. Two sub-layers can also be distinguished, but they coexist only in the area adjacent to the beginning of delamination. In the middle of the treadmill, the

layer consists of abraded steel bearing elements (measured hardness is  $809 \pm 18$  HV<sub>0,5</sub>) again hardened and hardened. Towards the edge of the treadmill, a foreign material layer consisting of a mixture of materials begins to appear (the measured hardness is  $290 \pm 15$  HV<sub>0,5</sub>). The thickness of the foreign material is in the range of 105-196  $\mu\text{m}$ , which is much less compared to the bearing A. The layer with the largest thickness is located in the central part of the treadmill.

12. Microstructure of the central part of the outer race of bearing B, with indication of the place of measurement of the hardness of the layer

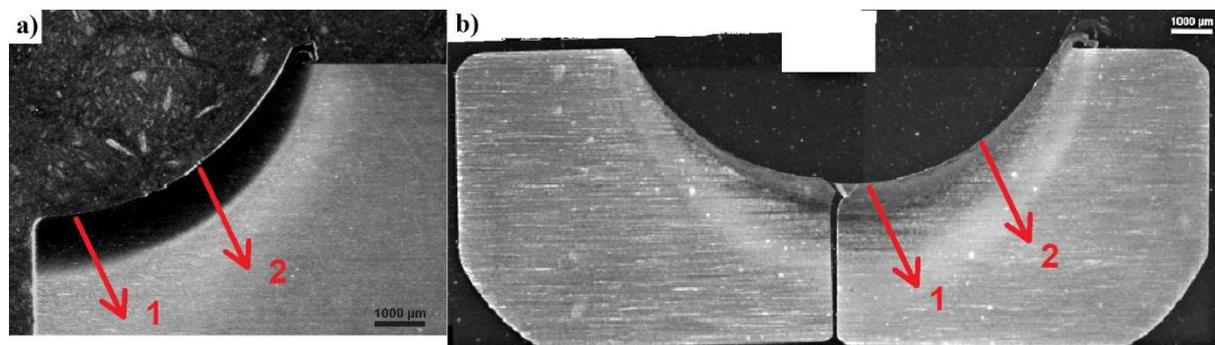
The etching of the half-rings of the internal ring samples in both cases revealed the SDC. Another feature common to the damage of the half-rings is the presence of a flash at the edge of the treadmill, which is the effect of the plastic deformation of the treadmill. A layer of foreign material, most likely a mixture of steel and bronze from the separator, is also visible on the flash. The material microstructures in the SDC are similar to those shown in Figure 9b. In the case of the half-washers of the B bearing, there was a permanent connection at the edge of the treadmill, which cracked while cutting the half-rings.

13. Macroscopic photo of the nital-cut:  
a) Half-washer of the inner bearing A; b) both half-rings of bearing B

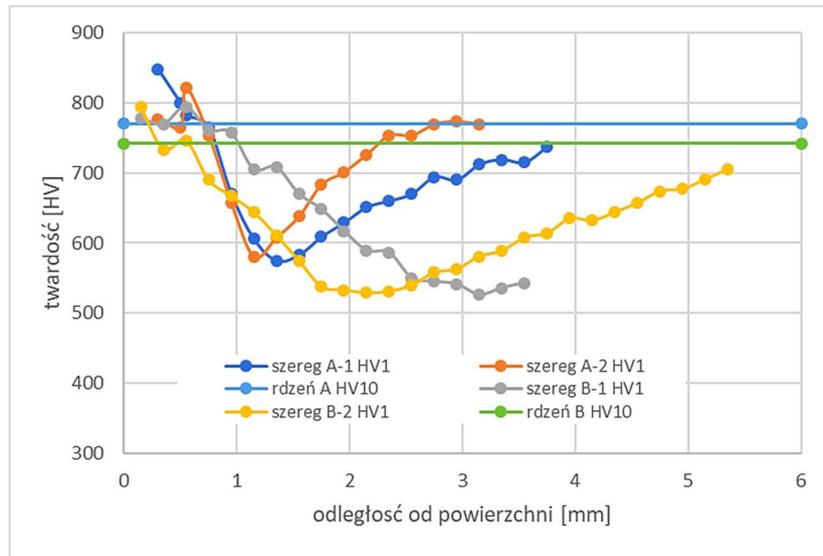
The SDC depth in the internal half-washers was also estimated based on linear hardness distributions (Fig. 14). The places of their execution are shown in Fig. 13. The "1" measurement series were made throughout the cross-section of the samples, which proves overheating of both half-rings, however, in the case of bearing A, the hardness curve tends to be measured in the core ( $770 \pm 7$  HV<sub>10</sub>), while the dependence for bearing B is approximately decreasing over the entire measuring section (material hardness in the core:  $742 \pm 20$  HV<sub>10</sub>). In the measuring series "2" of bearing B, the material has also overheated through, in the case of the bearing the depth SDC is approx. 2.7 mm.

14. Diagram of the hardness dependence on the distance from the surface of the inner and outer rings of the bearings A and B, taking into account the hardness measured in the cores of the samples

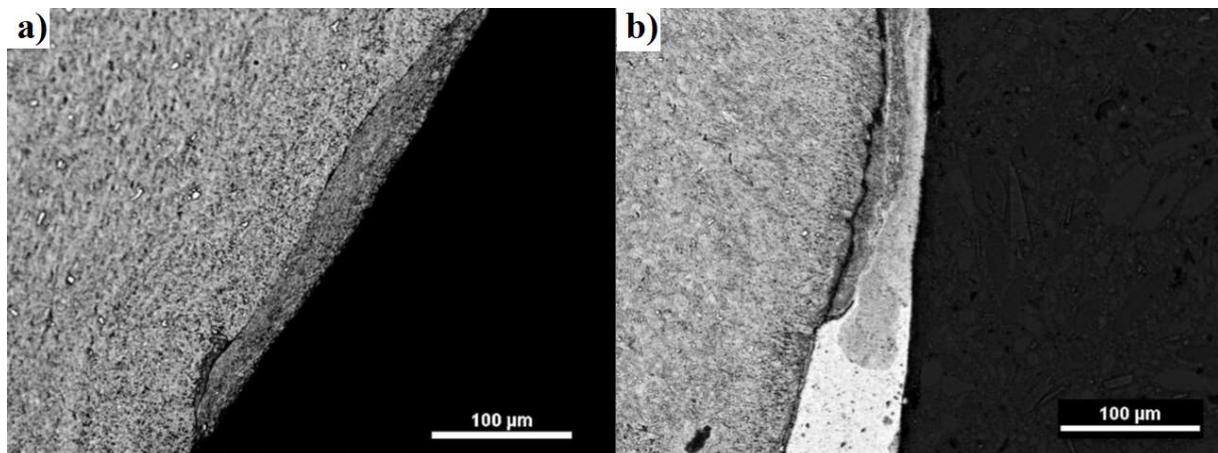
The microstructures of the ball cores of bearings A and B correspond to the microstructure shown in Fig. 9b, while the microstructures of the subsurface zones are shown in Fig. 15. In both cases, the hardening of the balls was found throughout. At the edges of the cross-sections, you can see the wipes and the material that has been attached to the surface of the beads.

15. Microstructure of the ball cross-section (nital etching) at the cross-section edge:  
a) bearings A b) bearings B

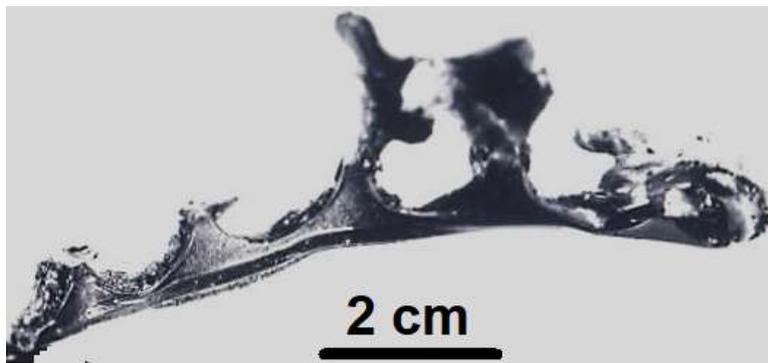
The bearing case from a light helicopter engine, in which the separator was also broken, and the cause of the failure was inadequate bearing lubrication was found in 1984 [6]. However, the separator, in contrast to the previously discussed cases, was torn apart into more pieces, the largest of which is shown in Fig. 16. The balls were largely abraded, the inner half-rings were distorted, and the foreign material from the grated filings was applied to the friction pairs.

16. Elements of the damaged bearing tested in 1984. with the selection of metallographic sampling sites [6]

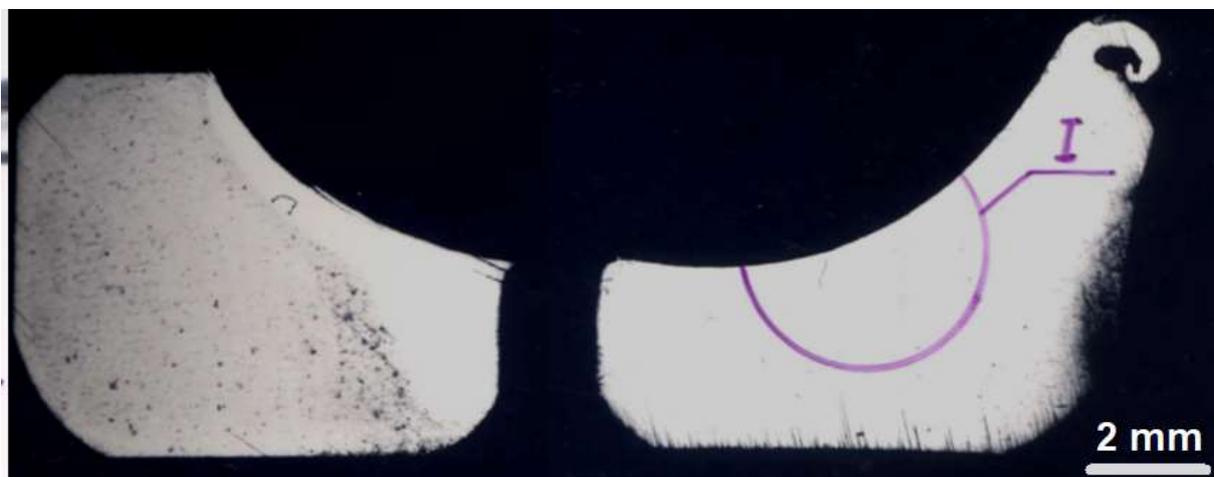
Observations of the inner-ring grinders (Fig. 17) revealed the presence of SDC (non-defective areas), much larger than the cases from 2016 and 2017. The SDC in one half-ring almost the entire sample, the half-ring is clearly distorted and has a flash at the edge of the treadmill. Observations of the microstructure of the half-ring in the area "I" (Fig. 18a) and beads (Fig. 18b) revealed the presence of microcracks. The microstructure of the outer treadmill resembled the one shown in Fig. 11a. The hardness of materials and their microstructure made in undamaged places met the technical requirements.

17. Spacing of cross-sections of samples of inner-ring nibs etched with nital, marking the place of observation under greater magnification [6]

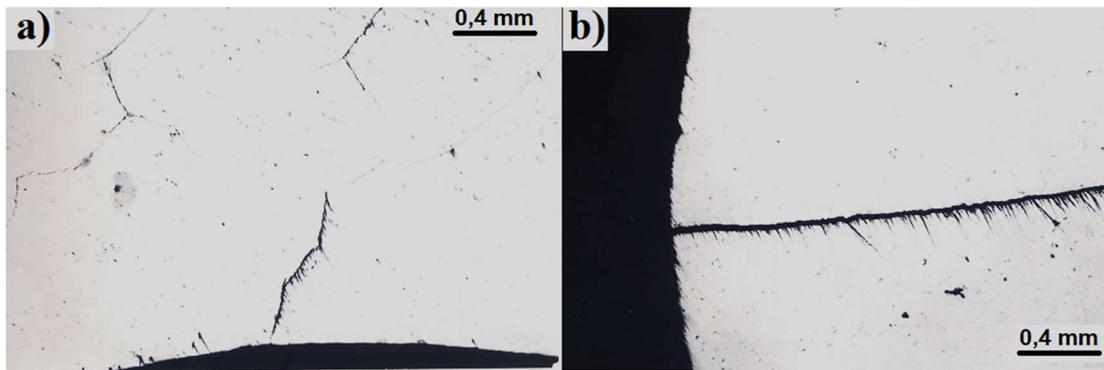
18. a) The microstructure of the section cut in the area marked in Fig. 17;  
b) The microstructure of the cross-section of the ball [6]

Significant distortion of the half-rings, balls, destruction of the separator and the presence of microcracks inside the ring and the ball indicate the destruction of the bearing at high temperature and with a significant increase in loads.

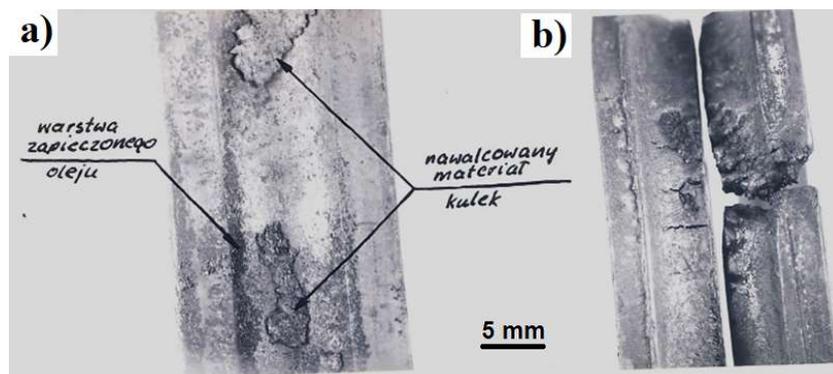
In the history of investigations of this type of bearings carried out at the ITWL, there have been cases of failure, the feature of which was the failure of the separator without its fragmentation. This type of event was examined in 1979 [2]. The damage consisted of significant deformation and ball clumping, application of the ball material to the outer race track and burning of the oil on it (Fig. 19a), plastic deformation of the internal half-rings (Fig. 19b) and their cracking. The separator wore traces of abrasion on the inner centering surface.

19. a) The surface of the outer race, b) The surface of the inner race [2]

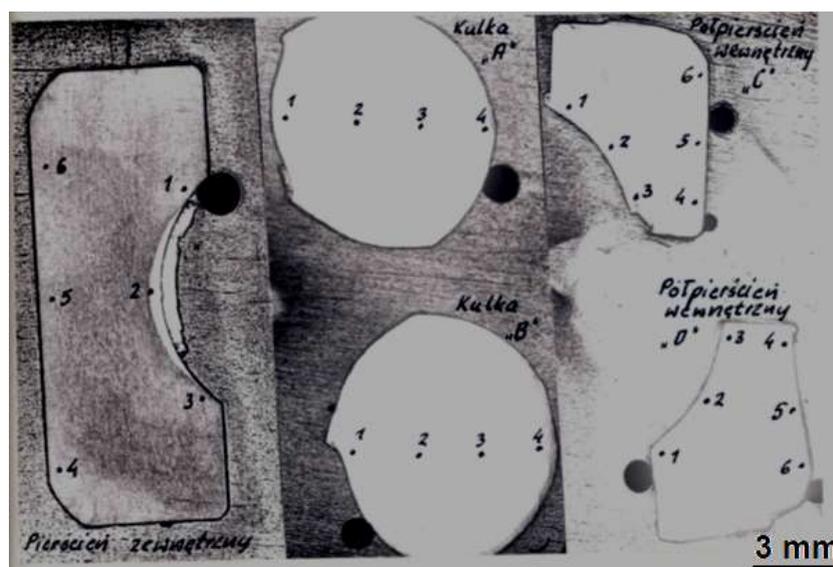
Fig. 20 shows the macroscopic images of section cuts of steel parts of the bearing. The edges were cut with nital. The outer ring has a relatively small thermal degradation zone (much higher in cases of 2016 and 2017) with a layer of ball material deposited in the middle of the treadmill. The beads and half-rings were resistant to the etching factor, which indicates overheating of these elements throughout. In addition, on one of the half-rings, there is a material flash at the edge of the tread near the above-mentioned cases. The studies on the microstructure and hardness of the outer ring outside the SDC do not raise any objections. In the case of internal half-rings and balls, the structure of undesired martensite was found, thus re-hardening the materials. The trace of seized oil on the outer treadmill indicates an insufficient supply of oil to the Bearing.

20. Macroscopic images of nital-etched cross-cuts of the outer ring, balls and internal half-rings with marking of hardness measurement points [2]
