Jacek Makuch

Politechnika Wrocławska

Examination of the cross-section shape of tram frogs

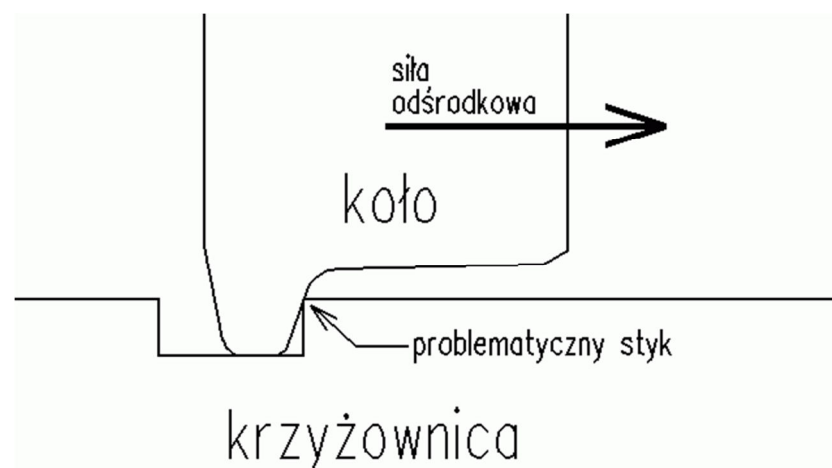
The first example is the research carried out for the reconstruction of tram tracks along Świdnicka, Widok, Szewska, and Grodzka Streets in Wrocław in 2005-07. In the newly built turnouts, monoblock crossings were used, whose shallowed grooves had the shape of a regular rectangle, 36 mm wide and 14 mm deep, and the tips and upper edges - did not have roundings. During the first test runs of the trams, there were problems with the wheelsets passing through the frogs - the rims of the wheels climbed onto the frogs, and after covering a dozen or so centimeters they fell back into the grooves, or only hit the frogs, causing, however, significant noise and vibrations. There were numerous traces of shearing as well as chipping and chipping of the rolling edges of frog grooves and run-on rails as well as crossing frogs' bows. Tracks were allowed for linear traffic, but only for older high-floor trams of domestic production, because modern low-floor Skoda 16T trams still had problems with crossing crossings. Thanks to the measurements carried out, the main cause of the problems was found to be the improper shape of the grooves in monoblock frogs and access rails with shallowing ramps - their rectangular shape did not correspond to the wheel rim profile. As a result, in the case of the groove for the curve located in the arc (Fig. 5), the wheel, under the influence of the centrifugal force, the contact of the inclined side surface of the rim and the sharp end of the upper edge of the groove, climbed up as if on a ramp and left the groove, resulting in a derailment.

5. Schematic diagram of cooperation between the wheel rim and the groove of the tram frog [3, 4]

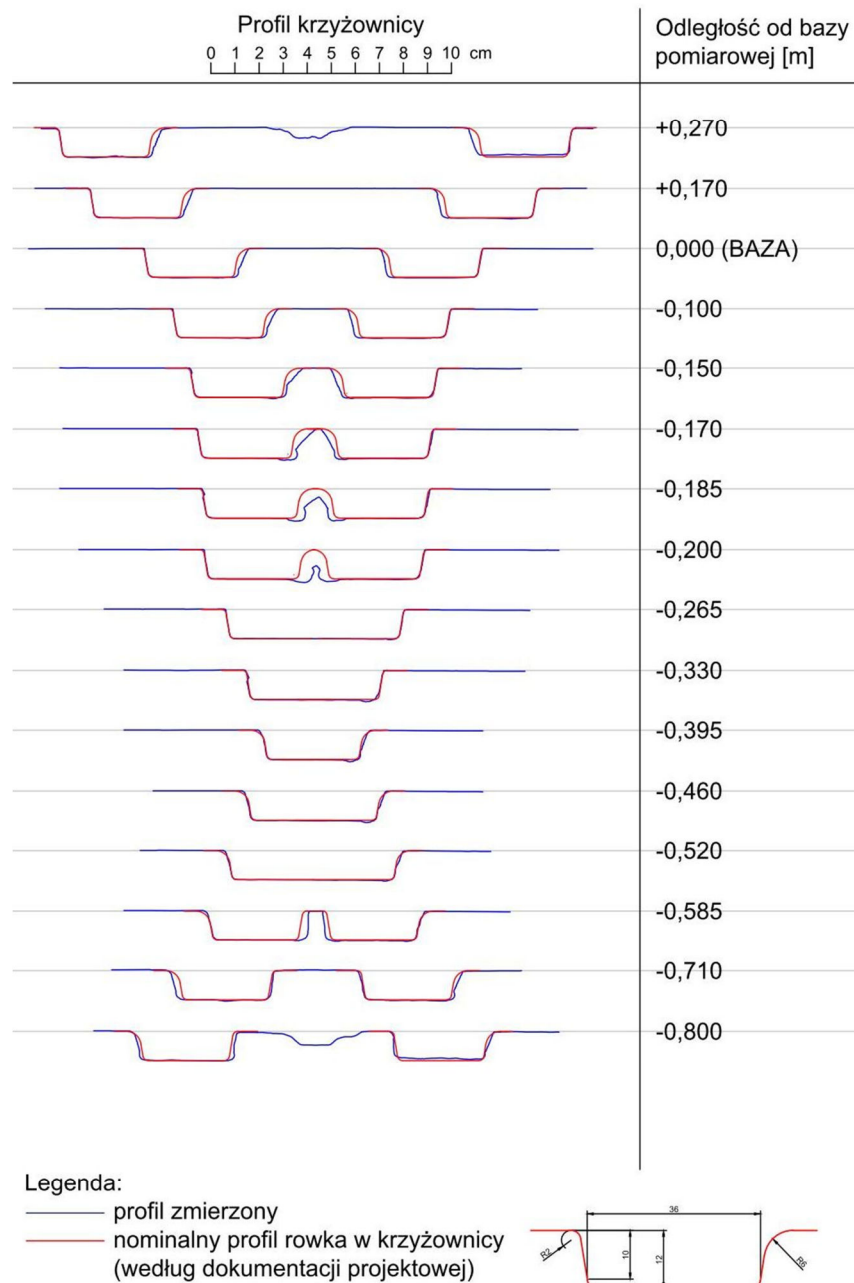
The second example is the research carried out on the Oporów tram terminus modernized in 2015. As a result of the reconstruction, this loop obtained a completely new geometric layout. In the first months of operation, there were several derailments of trams at the intersections of two entry turnouts. Just like on Szewska Street, modern low-floor trams (this time Pesa Twist) was derailed more often than older high-floor vehicles of domestic production, and even if there was no derailment, just like on Szewska Street - the rims of the wheels climbed onto the frogs, and then after driving several dozen centimeters they fell back into the grooves. This time, however, the grooves of the frogs did not (as in Szewska Street) have the shape of regular rectangles and sharp ends of upper edges. The turnouts used, however, had shallower grooves not only in the frogs but also in the rails of the "second" course (i.e. in the blades) - to avoid the effect of reverse cant in the arch. Observations and measurements carried out in the field showed that when entering the inner tracks - the nose of the frog was hit by the outer wheel of the first axle of the bogie, while when entering the outer tracks - the inner wheel of the second axle of the bogie hit the nose of the frog. Measurements of the cross-sectional shape of the tram crossings and steering wheels (Fig. 6) made during the tests allowed for simple graphical simulations of the passage of the tram wheels through these crossings and steering wheels (Fig. 7). Thanks to the measurements carried out, the main cause of the problems was found to be the improper shape of the grooves in the handlebars - limiting them only to shallowing them without simultaneously narrowing their width, paradoxically, instead of improving, unfortunately, it worsened the conditions of cooperation between vehicles and the track.

6. Measurements of the cross-sectional shape of a tram frog with a mechanical-electronic profile measurement gauge (developed by Adam Hyliński) [7]

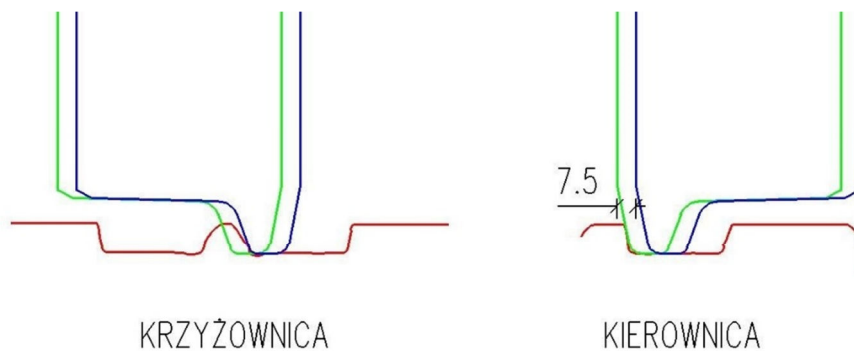
7. Graphical simulation of tram wheels passing through the frog and steering wheel [7]

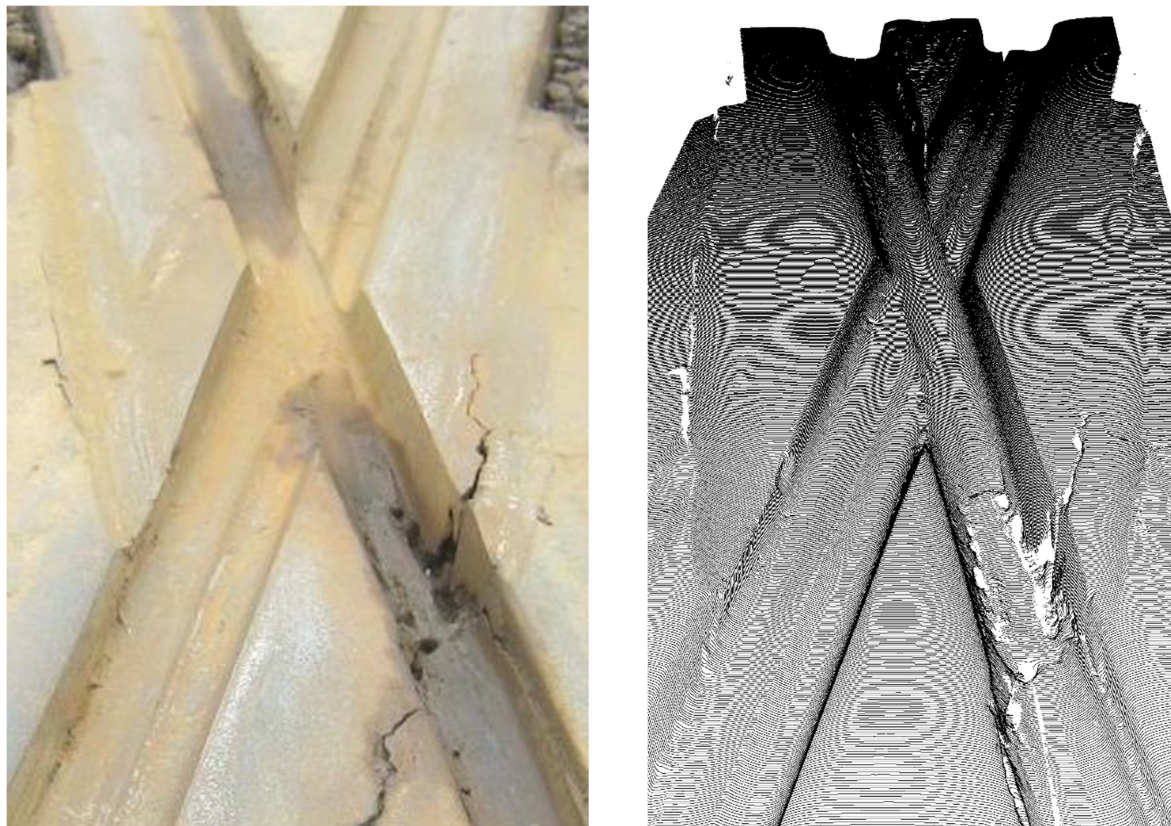
The third example is the research carried out in March 2020 on the Osobowice loop. These measurements were not related to the implementation of any expertise but resulted only from the need to learn how to use the laser scanner for track surfaces, which was purchased at that time. Figure 8 shows the tram frog of the first turnout on this loop. It was a frog about 20 years old, rail (not block), welded, curved (with a radius of 50 m in the turning track). This frog had characteristic (for tram traffic) forms of wear: two-wheel traces in an arc course, and one trace - in a straight course, as well as developing cracks and defects on one of the joints of its welded elements. Thanks to the measurement method used, in relation to the real object - documented here with a classic photograph, it was possible to generate its so-called digital twin, i.e. a digital twin.

8. Real view (left) and digital twin (right) of a tram frog [11]

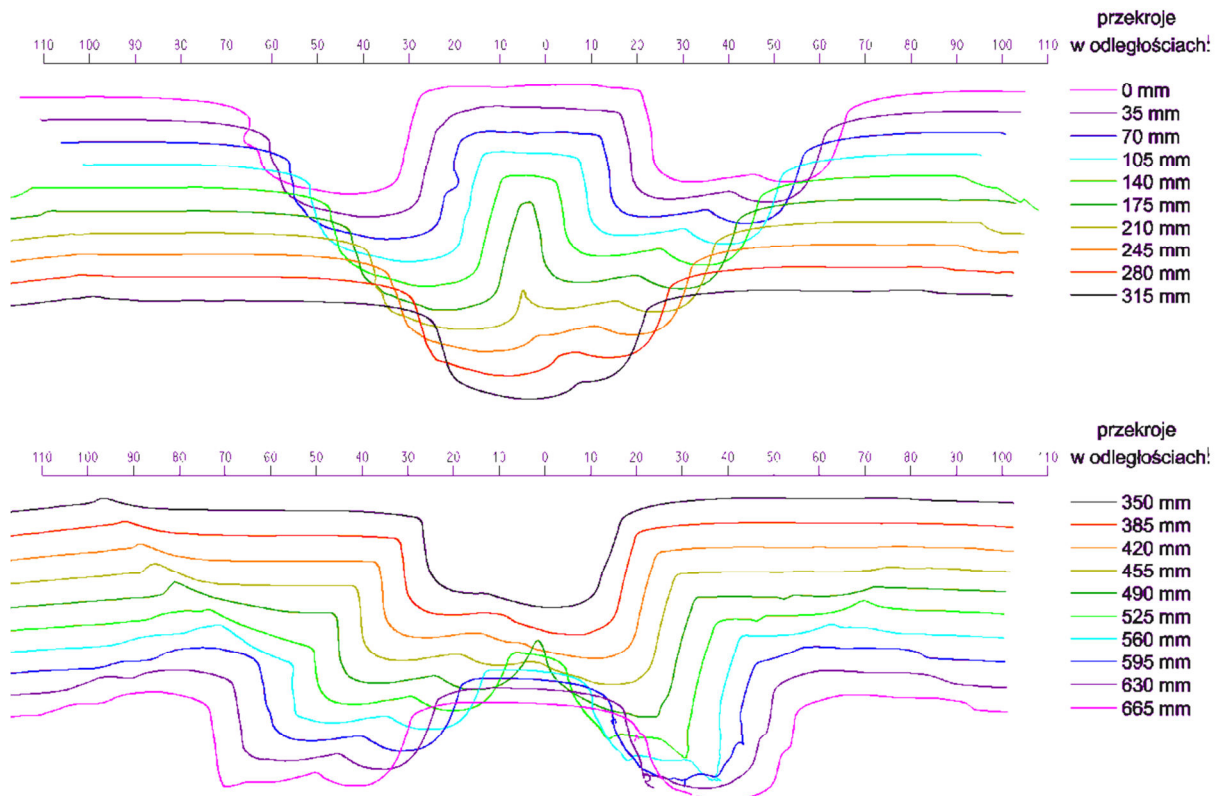
Figure 9 shows a series of successive cross-sections in a cascade view - better showing changes in the shape of the cross-section. The aforementioned characteristic wear patterns are visible.

9. Waterfall plot of cross-sections generated by the frog [11]
