Wojciech Szczepanek

The analysis of safety and traffic conditions on Orłąt Lwowskich Square in Wrocław

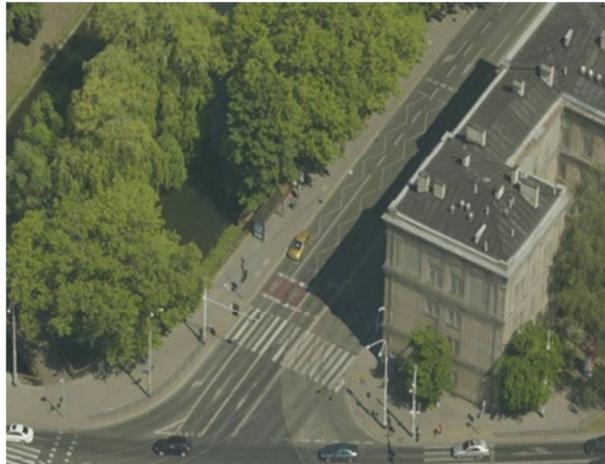
The first is the eastern entrance of Podwale Street to the intersection of Piłsudskiego Street - Podwale Street- Orłąt Lwowskich square shown in Figure 3. The biggest problem was the bus and tram stop located on the sidewalk on the right side, looking from the inlet. In Figure 3. Due to the location of the tram line separated by two traffic lanes with the P-17 marking "stop line", pedestrians had to walk 6 m in order to get safely from the stop to the communication vehicle and vice versa. This was a dangerous situation, as the moving vehicles might not notice the stopping tram and the leaving passengers. The psychological aspect is also important in this situation because the location of the stop near the inlet could make the driver want to accelerate the vehicle in order to be able to pass the green signal before people using public transport leave. In road engineering, the behavior of individual road users is important. Mainly the decisions they make, which the designer should predict and take into account when analyzing or designing solutions. Additionally, getting out of the tram onto the road was difficult due to overcoming a considerable height. Putting the problem still related to the location of the stop near the inlet is significantly reduced capacity because two lanes during the passage of passengers were blocked, or one when the bus stopped.

3. East inlet of Podwale Street within the intersection of Piłsudskiego Street
- Podwale Street - Orłąt Lwowskich square
Source: [9]

The eastern entrance to Podwale Street is shown in Figure 3. An island was built on the road axis to which the stop was moved. In addition, there is a bus lane on the tram track. Thanks to these solutions, all passengers' problems when getting off were solved and the inlet capacity was improved. The described area is presented in Figure 8.

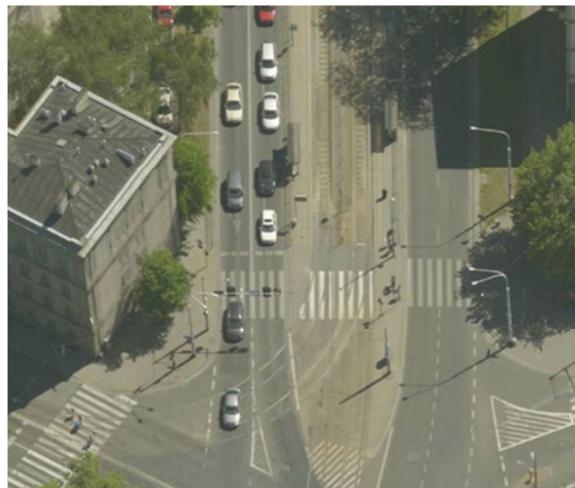
The second area is the southern inlet of Piłsudskiego Street, shown in Figure 4, in which the leftmost left lane looking from the inlet side, being a left-hand turn, had a low capacity. It was caused by heavy traffic, where at the specified peak time the number of passing vehicles was 464 and the green signal was 12-15 seconds long. The problem was that the green signal was too short and it was not possible to extend it, as it would require shortening the remaining phases by a few seconds. In addition, the given left-turn required the implementation of an additional phase of the movement, which took additional time of the green signal from the other signaling devices. The possibility of removing this relation would increase the capacity of the remaining inlets. There were also one-way bicycle paths at the edges of the road. Each of them is 1 m wide, where according to [1] the minimum width for such paths is 1.5 m, and according to [7] the recommended width within the city of Wrocław should be 2 m. It is inconsistent with the guidelines and poses a threat to the safety of bicycles traveling within Piłsudskiego Street.

4. The southern inlet of Piłsudskiego Street within the intersection of Piłsudskiego Street
- Podwale Street - Orłąt Lwowskich square
Source: [9]

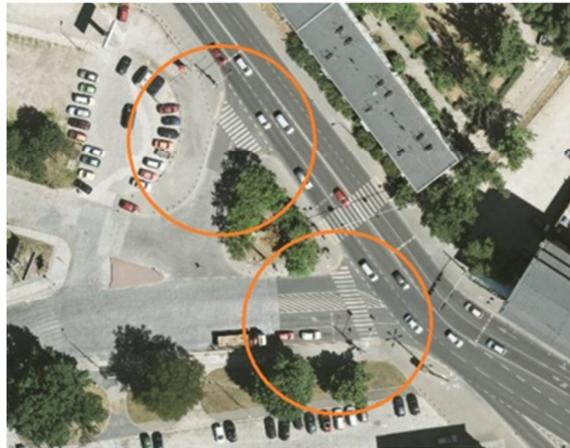
Another area is the southern inlet of Robotnicza Street within the intersection of Robotnicza Street - Orłąt Lwowskich square shown in Figure 5. In this case, the problem is the crossing of two streets at an angle of 60° , which significantly reduces the visibility. According to the regulation [1], the road intersection angle should be 90° , with a deviation of 30° allowed. This value is significantly too low. The condition of the northwest visibility was also not met, as the trees on the island blocked the field of view at this angle. Additionally, the traffic volume at the inlet was 536 vehicles in the rush hour, while the north-west inlet at Orłąt Lwowskich square amounted to 1,227 vehicles, which illustrates poor traffic conditions. Given the characteristics of the area, it can be concluded that all safety conditions should be met.

The last area is the northwest entrance of Robotnicza Street within the intersection of Robotnicza Street - Orłąt Lwowskich square shown in Figure 5. The traffic intensity of the inlet of Robotnicza Street turns out to be much smaller than that mentioned in point 3, but the road intersection angle is 48° . This is not in line with the regulation [1] and should be amended. The field of view was limited to the east due to the trees situated by the island and by the angle of the entrance leading to the Orłąt Lwowskich square.

5. South and the north-west inlet of Robotnicza Street within the intersection of Robotnicza Street- Orląt Lwowskich square

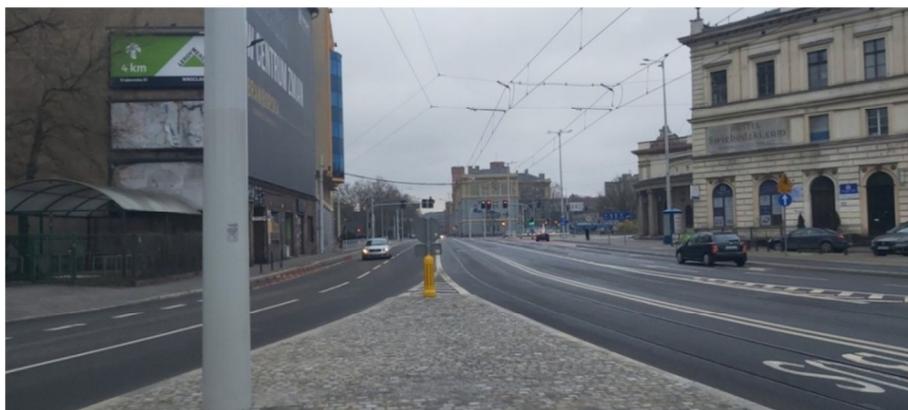
6. The view from the rebuilt area in Figure 5 towards the intersection of Piłsudskiego Street - Podwale Street - Orląt Lwowskich square (eastern direction)

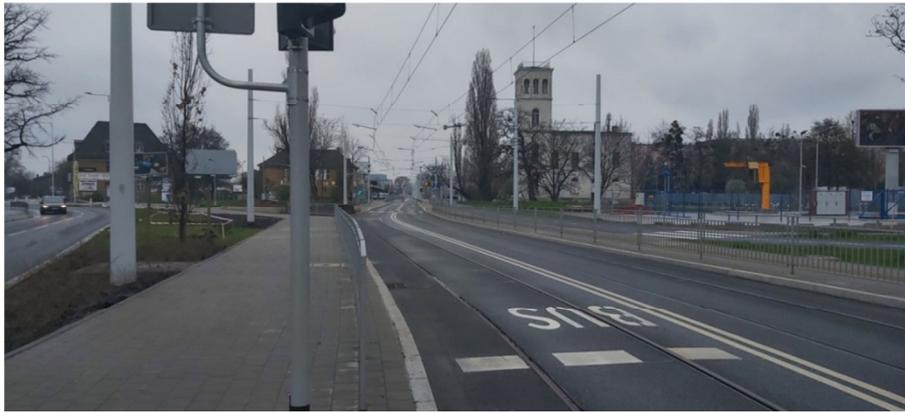
7. The view from the rebuilt area in Figure 5 in the opposite direction to Figure 6 (west direction) *Source: [own photo]*

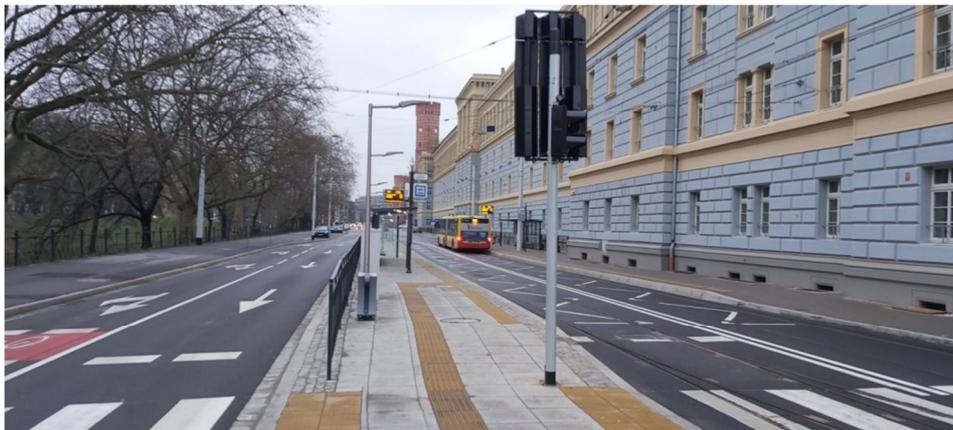
8. View of the eastern inlet of Podwale Street after the reconstruction *Source: [own photo]*

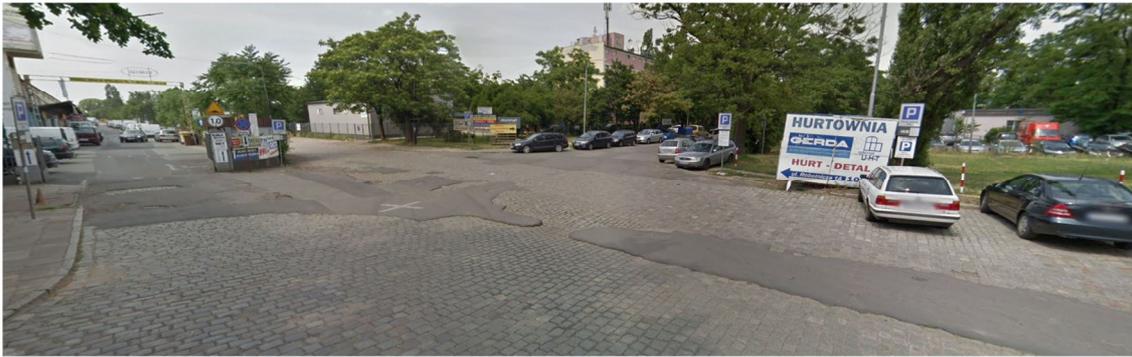
The construction of the tram and bus line "TAT", together with the solutions used in Figures 6 and 7 in the area in Figure 5, forced the reconstruction of the intersection of Robotnicza Street - Nabycińska Street from Figure 2. Originally, the traffic volume did not exceed 1000 vehicles a day within the above-mentioned area, but after the changes in traffic organization, all participants who previously moved from the north-west through Orłąt Lwowskich square are forced to follow Nabycińska Street and only then join the traffic on Robotnicza Street in the southern part to get to the intersection of Piłsudskiego Street - Powale Street - Orłąt Lwowskich square. In addition, the tram line crosses the described street, and thus forced the creation of traffic lights. The described intersection is shown in Figure 9 before the reconstruction and Figure 10 after the reconstruction. In addition to the use of traffic lights in a critical point, the pavement was rebuilt, the road was widened by one lane and the horizontal and vertical markings were completed.

9. View of the intersection of Nabycińska Street - Robotnicza Street before the reconstruction
Source: [2]

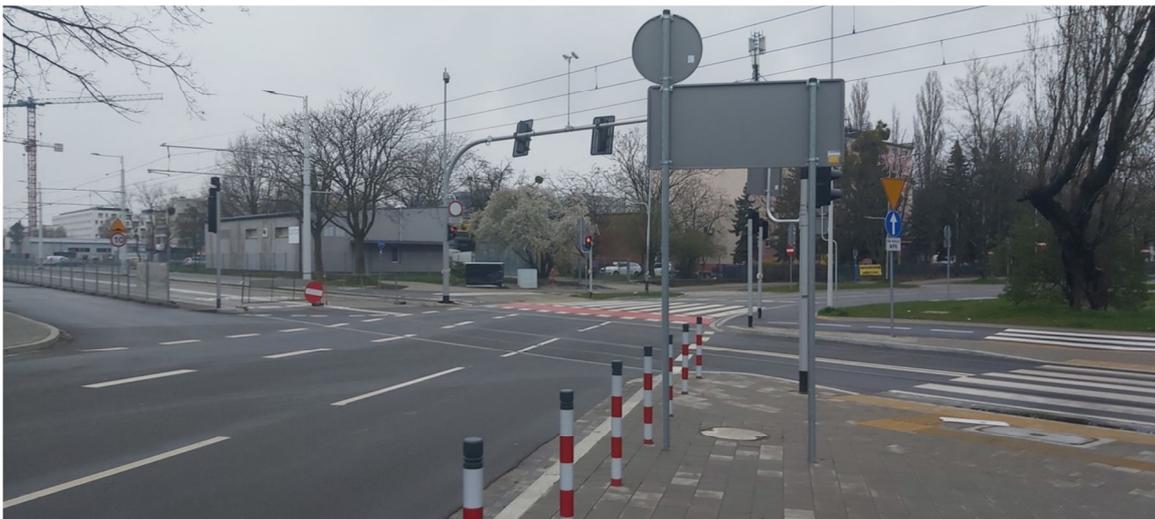
10. View of the intersection of Nabycińska Street - Robotnicza Street after the reconstruction
Source: [own photo]
