Jacek Makuch

Politechnika Wroclawska, Wydział

DOI: 10.35117/A_ENG_19_06_01

Measurements of transverse section wear of rails in tracks of tram-loop

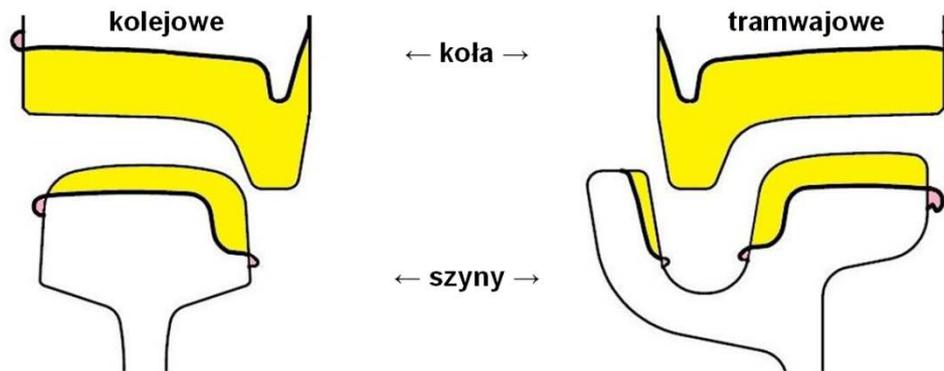
With the passage of time, differences in the shapes of wheel and rail sections appear in actual rail vehicles and tracks - actual compared to nominal. Fig. 1 presents the most common wear shapes on the rim and steel surface of the tracks - for both rail (head) and tram (grooved) rails).

1. The most common shapes of wheel and rail rim wear [1]

The most important reason is the friction wear on rolling surfaces, which is the result of friction and impact - steel wheels on steel rails. These are "losses" of material (highlighted in Fig. 1 in yellow). At the boundaries of the rolling surfaces, runoff may occur in the form of bulges, i.e. "excess" of the material (highlighted in Fig. 1 in pink) - resulting from displacements of plasticized steel, and if so - they are not only excess but also defects. The shape of the running surfaces of operated rails can also be changed as a result of deliberate actions such as reprofiling (grinding) or regeneration (surfacing and grinding).

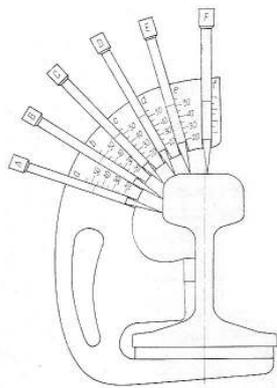
2. Graver device

The oldest and at the same time the simplest are discrete measurement methods. Most often they are made with calipers. However, this is an indirect measurement - by measuring the height of the entire rail and subtracting from its nominal size, we determine its vertical wear, similarly to horizontal wear. To facilitate measurements, devices enabling direct measurement were developed – such graver device (Fig. 2) and template profile gauges (Fig. 3).

Unfortunately, graver devices usually define "their" measuring places, not necessarily the same which the regulations require us to check. In turn, the template profile gauge presented in Fig. 3 determines vertical wear exactly in the middle of the rail head width - which in real measurements of heavily worn rails is not always the case.

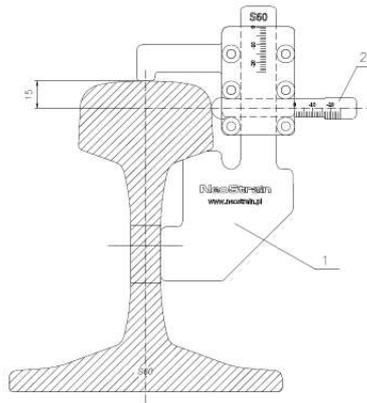
3. Template profile gauge [4]

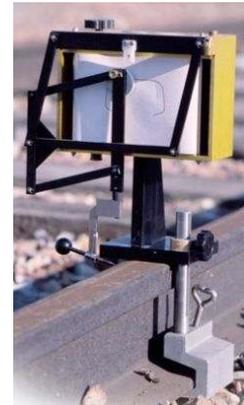
4. Mechanical profilograph [5]

Newer methods are continuous measurements. They are made possible by devices such as mechanical profilographs (Fig. 4), in which the movement of the guide stick guided by hand on the rail surface causes the drawing of its section shape on paper. Much more modern devices enabling continuous measurements are mechanical-electronic profile gauge (Fig. 5) in which we still have to manually outline the rail with a guide or optical-electronic (Fig. 6) where the measurement takes place completely automatically, thanks to the use of laser scanning technique.

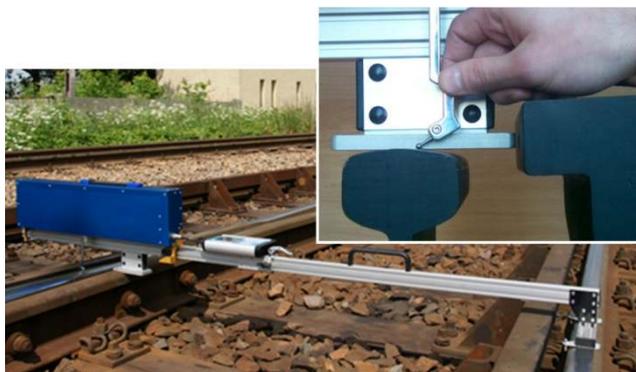
5. Mechanical-electronic profile gauge [6]

Only the last two devices allow measurement with an accuracy of 0.1 mm, all previously mentioned - only up to 1 mm. Although vernier calipers have vernier, it is necessary to take into account errors in applying the device when making measurements. On the other hand, the regulations do not require accuracy greater than 1 mm.

At each of the stations, the shape of the wear of the left and right rails was measured with a mechanical and electronic profilometer by GRAW (Fig. 5), and in addition to connect the measurements of the shape of the wear of both rails - width (clearance) and cant with a SOLA mechanical track gauge.

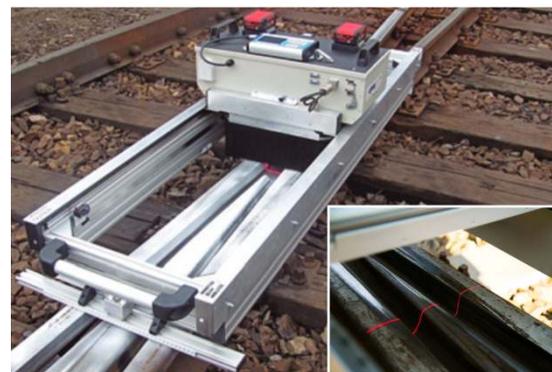
6. Optical and electronic profile gauge [6]

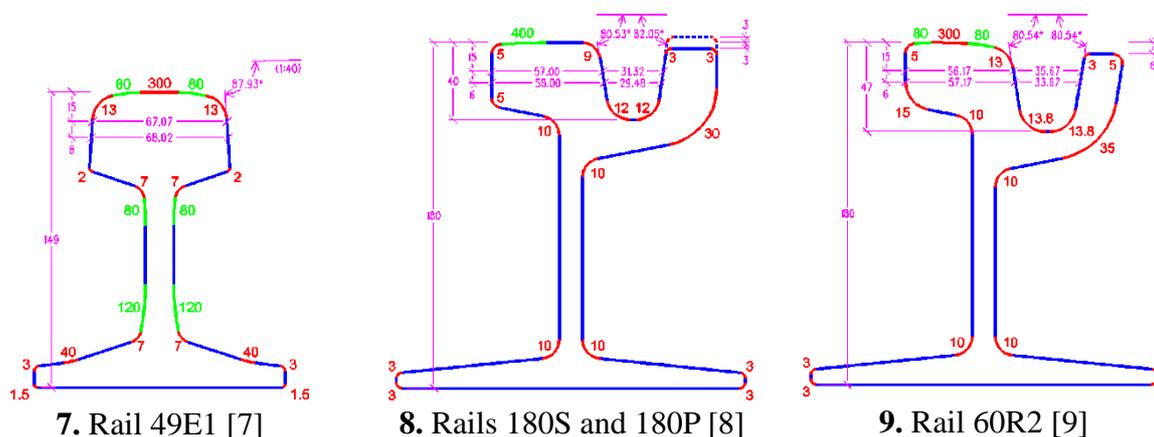
Figures 7, 8 and 9 show such cross-sections, while the form of their presentation differs from the one presented in the standards, as they were modified by the author of the article for the needs of teaching. Colours indicate different cases of sectional curves: blue are straight sections, and red and green are arches. The numbers given are the values of the radius of the arcs. Pink dimension lines are nominal dimensions, but only some (there are many more in standard drawings). Only the dimensions needed to determine the wear of the rail section are shown, i.e., for example, the width of the railhead 15 mm below its upper level - however, it should be noted that with high vertical wear this dimension increases (by 1 mm for 8 mm of vertical wear of the 49E1 rail), which is sometimes reason for lowering the determined values of side wear if we do not take it into account. The angle of inclination of the lateral surface of the rail type rail head (49E1) is given for its inward tilt of 1 to 40.

For tram (groove) type rails - two older types are shown in one illustration (Fig. 8) because they differ only in the upper end of the guide (the higher guide, shown in dashed line, is the 180P rail). The inclination angles of the side surfaces of the head and the guide are slightly different in the newer rail (Fig. 9) than in the older ones (Fig. 8), where they are additionally different for the head and guide, and generally (for the newer rail and both older ones) for the heads about 7 degrees smaller than in a rail (head) rail. In Fig. 8 and 9 there are much more pink dimension lines than in Fig. 7 - this is due to the fact that built-up structures are used much more often than in railway tracks, and then vertical wear can only be determined based on the location of the unused bottom groove or unused upper guide surface, while lateral wear - based on the location of the unused side guide surface. But if the bottom of the groove and the guide are worn - built-up tram tracks cannot be determined by caliper measurements for vertical and lateral wear. Figs. 8 and 9, similarly to Fig. 7, show the increase in the nominal dimension of the rail head width along with the increase in its vertical wear, which this time progresses at a faster pace, as 1 mm increase is obtained with only 6 mm vertical wear. With maximum vertical wear of 18 mm, we can, therefore, lower the specified side wear by up to 3 mm. If, however, we use the width of the groove as the nominal dimension - then the growth rate is twice as high (2 mm per 6 mm vertical wear).

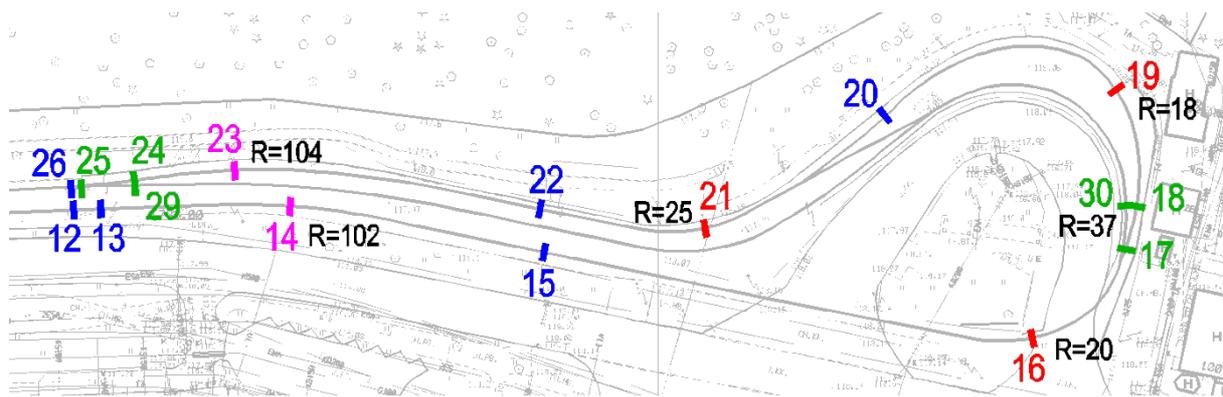
10. Sępólno loop - measuring stations (colour: blue - straight sections, pink - gentle arches, red - tight arches, green - junctions) and radii of arches

The measurements were taken on August 18, 2017, between 10 am and 1 pm, in nice sunny weather. At the beginning of the measurements, the air temperature was 23°C and at the end 30°C, while the rails - 36°C and 44°C, respectively. To measure the wear of the sections of the rails, 17 characteristic places (positions) were selected along the length of the loop (Fig. 10): 6 - on a straight line, 2 - in gentle arches, 3 - in tight arches and 6 in turnouts (including both straight sections and arches).

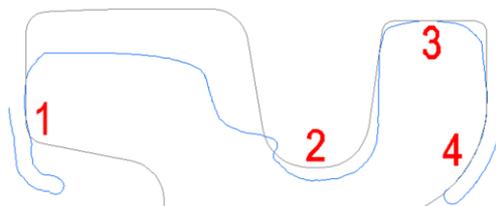
11. Application of the worn rail shape section (blue) on the nominal (gray) based on reference surfaces (red)

For each position, the analysis was carried out in the following three stages. The first stage (Fig. 11) consisted in applying a worn section to a nominal one, based on the reference surfaces - those parts of the section shape that should not have worn. In the case of grooved rails, these are (according to the designations in Fig. 11):

- 1 - side and bottom of the rail head (on the outside of the track),
- 2 - bottom of the groove,
- 3 - guide bar top,
- 4 - side and bottom of the guide.

Application was carried out by the method of subsequent tests. One reference surface was fitted and the matching effect was checked for the others. To do this, close-ups of the drawing view were used as accurately as possible, and binding tools were used. Sometimes it was possible to get fit in all four checked places. Mostly, however, at least one or two of these places did not match the others. In the example analyzed in Fig. 11 (station 14, left rail) these were the bottom of the groove and the bottom of the rail head (although the side already fitted). It was therefore necessary to decide which of the matches are less reliable and should not be included. In the analyzed case, however, it was considered that the bottom of the groove was subject to wear as a result of corrosion, because the analyzed cross-section was in the place of the concave track bend and even during measurements in the "solid" groove, although rainfall occurred a few days earlier. Similarly, it was considered that the bottom of the head was distorted as a result of excessive corrosion or adherence of a foreign body, or the occurrence of both of these combined.

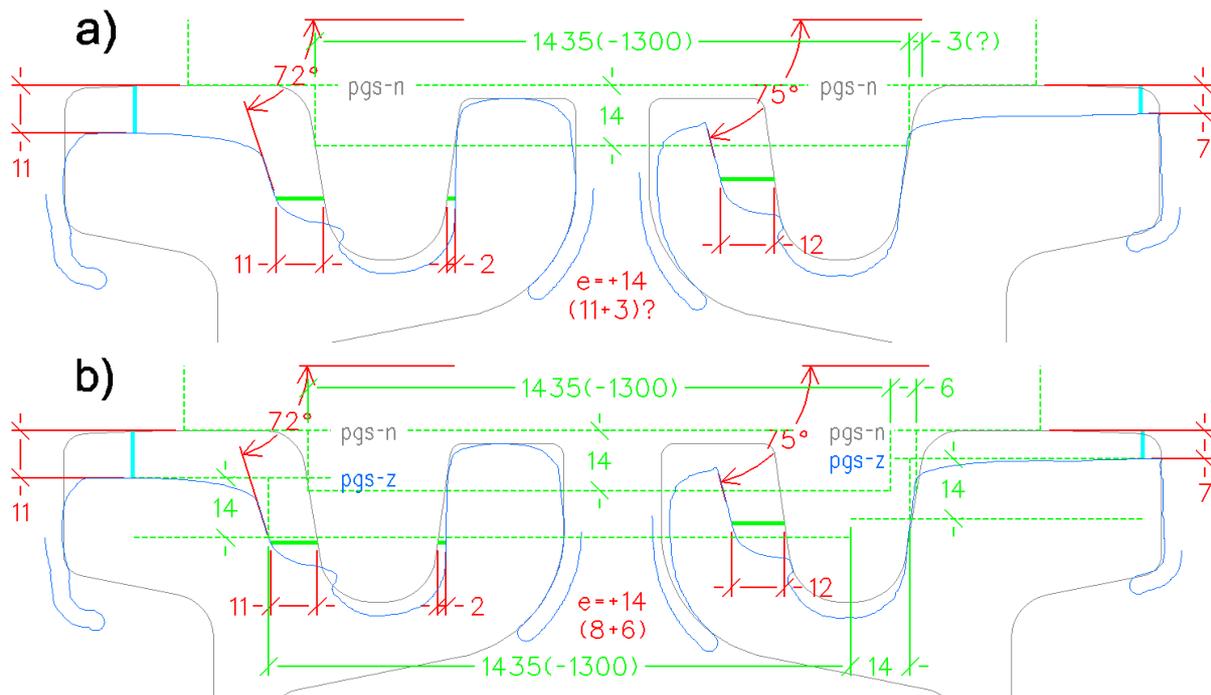
12. Shape sections of the left and right rails with specified wear values, oriented relative to each other based on a nominal (a) or actual (b) track gauge

The third stage is setting the sections of the left and right rails relative to each other, first nominally (Fig. 12a), then - taking into account the measured actual track width (Fig. 12b). The case (station 14) analyzed in Fig. 12 is a track located in the right arc with a radius of $R = 102$ m, with rails over 30 years old. Therefore, it is not surprising that the lateral wear of the left railhead and right rail guide, as well as the lack of slight lateral wear of the right railhead and left rail guide, and relatively high vertical wear (greater in the outer arc). Inserting the right rail next to the left (Fig. 12a), first, the mirror image of the first was made, then the railheads were leveled for nominal cross-sections (pgs-n), and then the cross-sections were removed so that the nominal width of the track 14 mm below pgs-n. However, for better readability of the graphic analysis, instead of 1435 mm, the dimension was 1300 mm smaller, i.e. 135 mm - then both rails in the drawing appeared next to each other. Finally, the rails had to be spread apart to match the actual track gauge (e) measured. In the analyzed case it was just +14 mm (i.e. 14 mm widening). Using the logic known from the measurements of rail wear made with a caliper, since the lateral wear of the left rail was 11 mm and the right rail did not occur (0 mm), the 14 mm widening consisted of: 11 mm resulting from side wear and only 3 mm caused by operating rail splits. In the analysis carried out, the rails had to be separated from their nominal position by 3 mm.

Except that when measuring the width of the used track, the track gauge was applied not to the rails with nominal sectional shapes but used, therefore, returning to the graphic analysis (Fig. 12b), the right rail was moved away from the left rail so that the real track width measured (1435 mm enlarged by the track gauge) by 14 mm widening) get 14 mm below levels of railheads for worn sections (pgs-z). It turned out then that the nominal cross-section of the right rail moved away from the left not by 3 mm but by 6 mm.

To sum up the considerations, in the track extension of 14 mm in the analyzed case: only 8 mm was the result of wear on the side rails, and as much as 6 mm was due to their mutual separation. It may seem a little illogical, but only a thorough graphical analysis allows you to understand the difference in this way of inference, compared to the analyzes carried out only computationally - used for measurements made with calipers. The reason for this discrepancy is the vertical rail wear in addition to the lateral ones. The larger they are, the greater the divergence of both methods of inference appears. Conducting the three stages of graphical analysis of the results of the measurements presented above is the starting point for further possible analyzes, which can be both graphical and purely descriptive (tabular, computational). After obtaining correctly applied sections used for nominal, we can compare them with each other - for example, different types of track geometry, but at the same age, or vice versa.

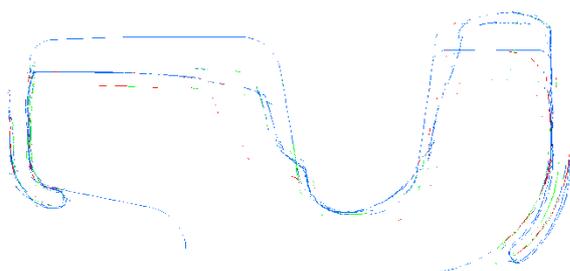
13. Comparison of rail wear shapes of the same age but for different cases of track

geometry (description in the text)

Fig. 13 presents a comparison of the shapes of rail wear at about 30 years of age for various cases of track geometry:

- outer rails in arches (red) - clearly the largest side wear of the heads; vertical wear mostly high; asymmetrical side wear (heads against guides),
- internal rails in arches (green) - here, in turn, the greatest side wear of the guides; whereas the vertical heads are usually small; side wear also unsymmetrical,
- rails in straight sections (blue) - average wear, both vertical and lateral, the latter rather symmetrical.

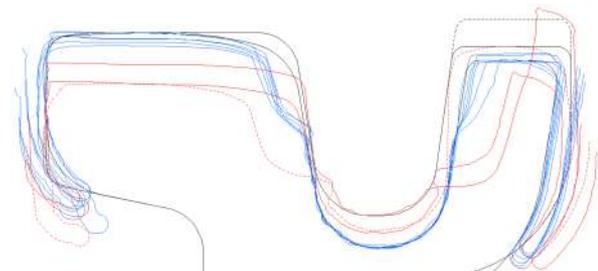
14. Comparison of rail wear shapes of the same age but for different cases of track

geometry (description in the text)

Fig. 14 shows a comparison of rail wear shapes in arches for different ages:

- rails around 5 years old (blue) - clearly much less wear,
- 30-year-old rails (red) - here much more wear, with lateral ones - interchangeably (i.e. if not the head, then the guides).

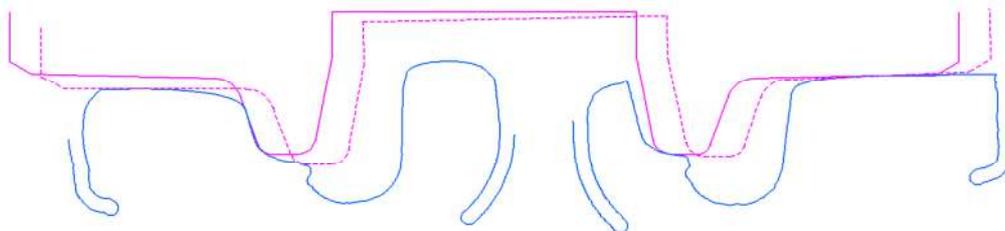
15. Analysis of cooperation between tram wheel rims and worn rails

The nominal sections of the rails are shown in gray in both drawings. After obtaining correctly oriented used cross-sections of the left and right rails, we can "set" tram wheel rims on them - with nominal shapes (Fig. 15) or with different degrees of wear, which gives the possibility:

- consideration of different cases of mutual positions,
- analyzing the causes of shape wear both rails and rims.
-
