Inspection of the technical condition of scaffolding using unmanned aerial

Evaluation of the technical condition of construction scaffolding - a case study

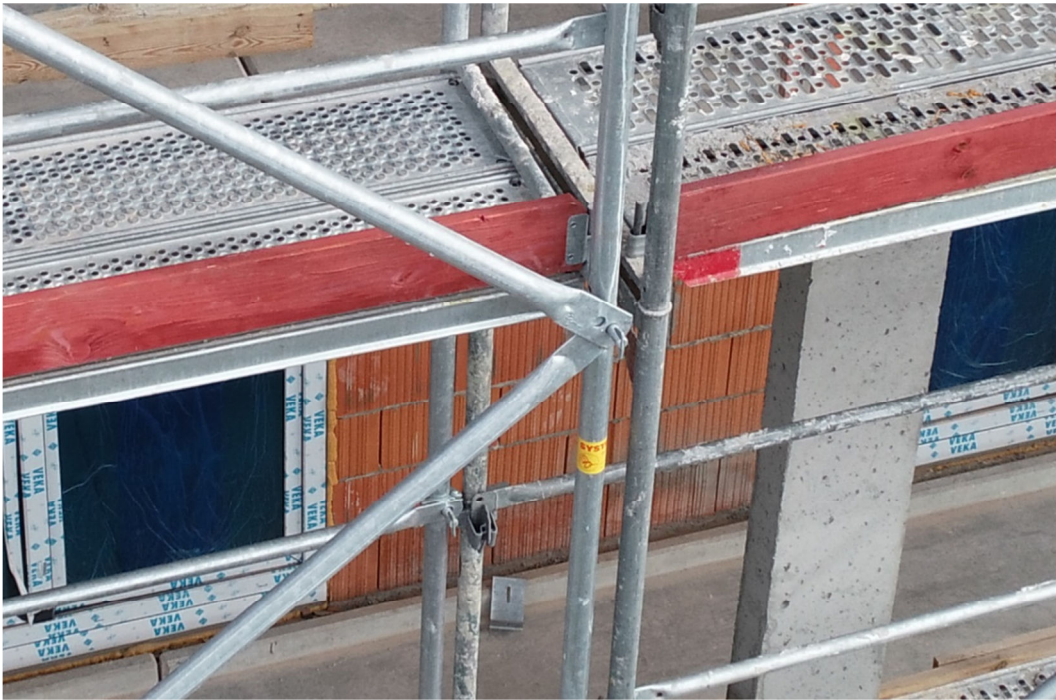
For example, Figure 1 shows a photo taken with a drone camera - a detail where you can see the connection of the working platform and braces with the main frame.

1. View of the scaffolding construction detail - connection

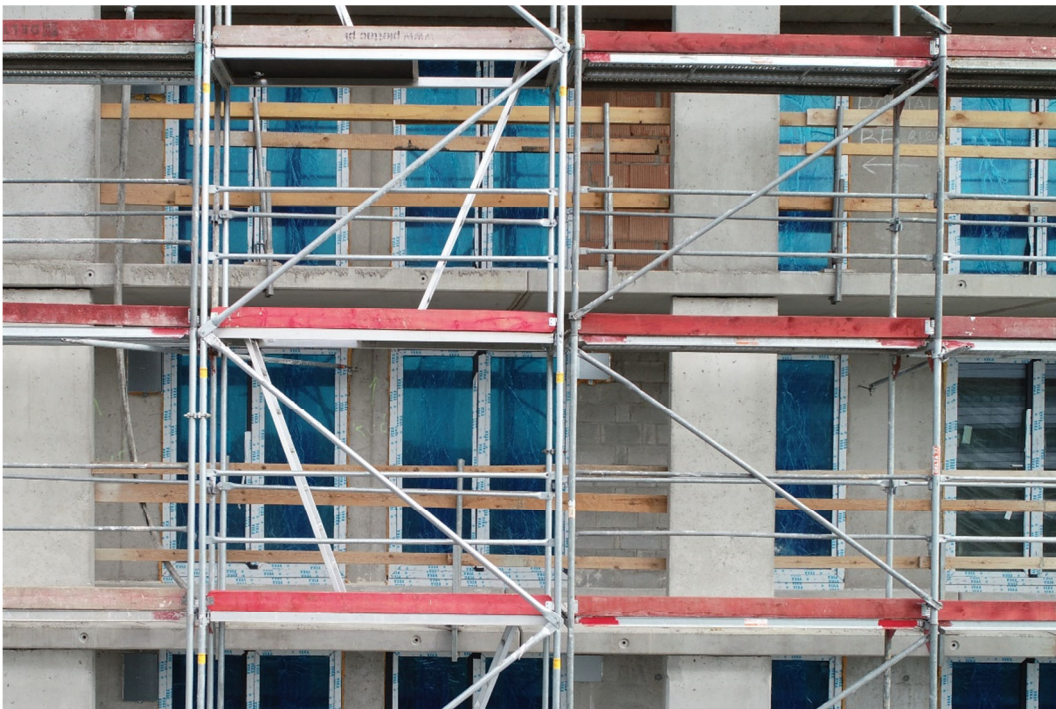
The acquired extensive photo and video material allowed for a detailed assessment of the scaffolding geometry and analysis of the components of the scaffolding without the need to climb onto the tested scaffolding. The assessment of the geometry and technical condition of the scaffoldings using the collected test material can be performed both in terms of quantity (e.g. verification of the completeness of the structure components) and qualitative aspect (e.g. identification of damage) in terms of, among others: correct assembly of braces, railings and boards curbs (figure 2) and scaffolding equipment elements, e.g. winches (figure 3).

2. View of the scaffold bracing perpendicular

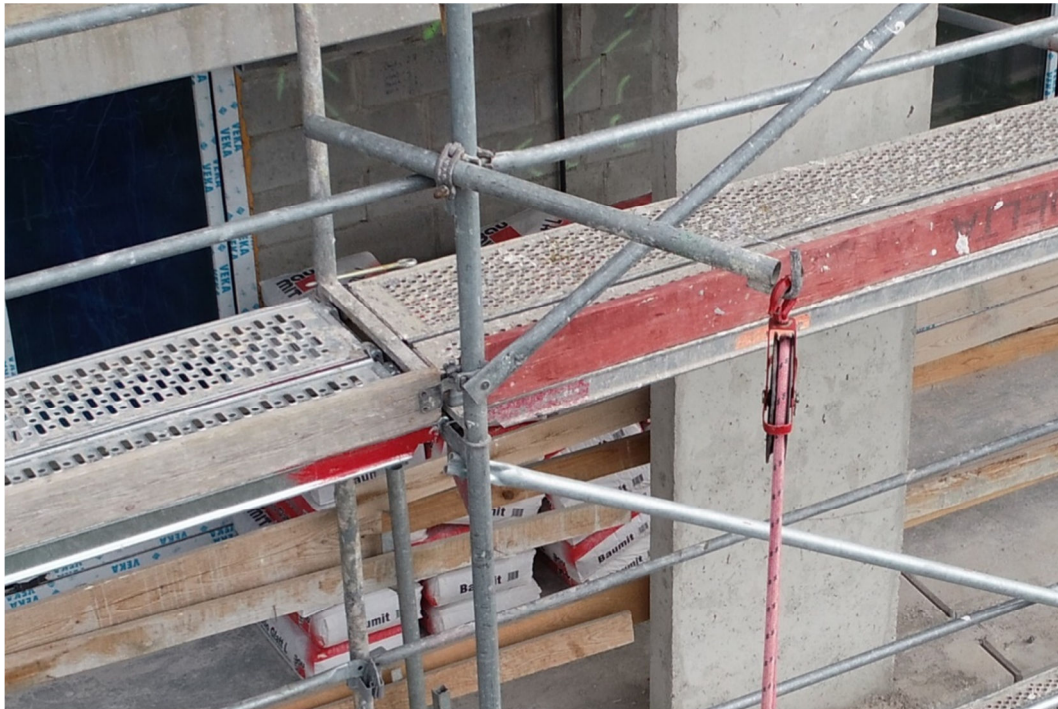
3. View of the winch

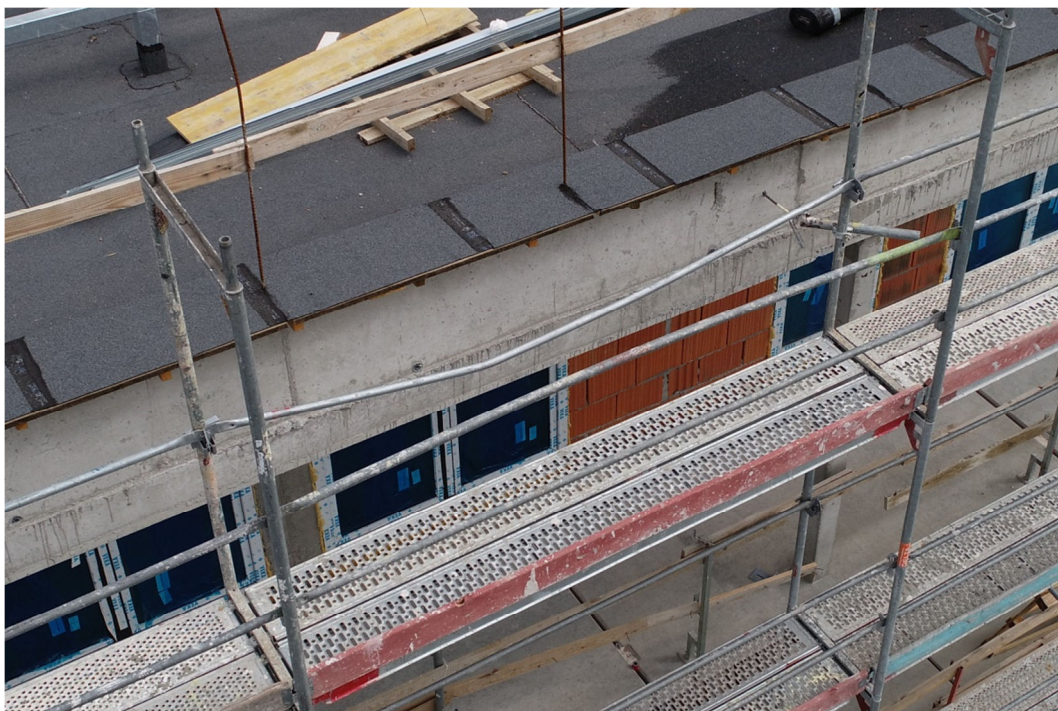
The drone used during the inspection also made it possible to efficiently locate structural damage, which may be a source of danger to scaffolding users. An example of such damage may be a bent handrail (figure 4) or a cracked curb board (figure 5).

4. View of the damaged handrail

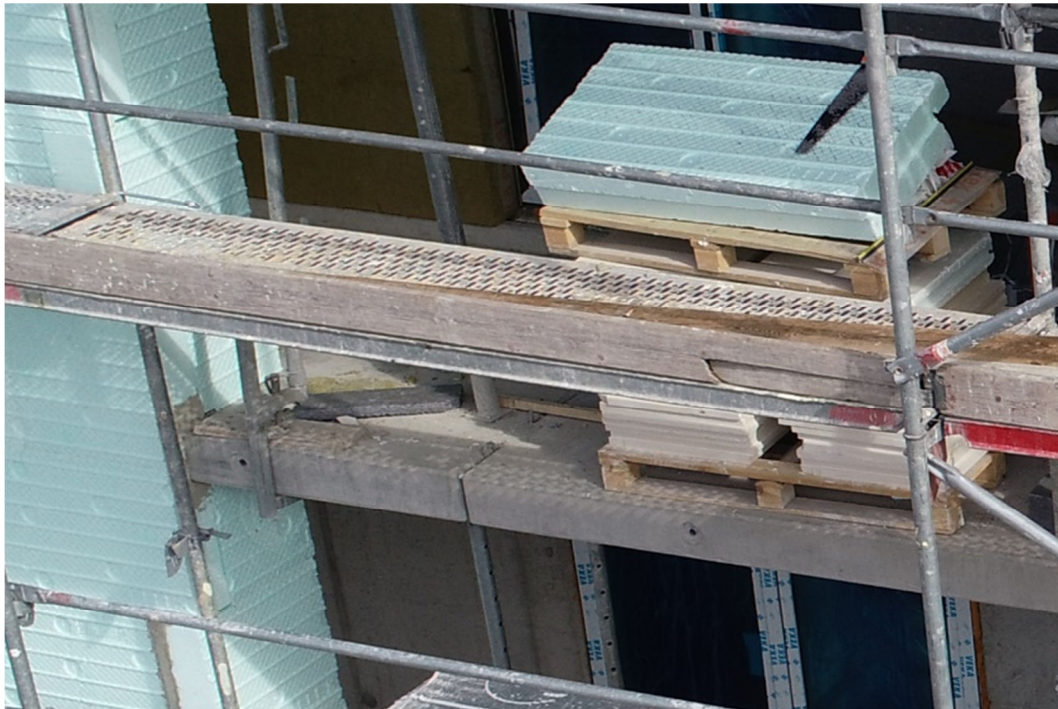
5. View of the damaged curb board

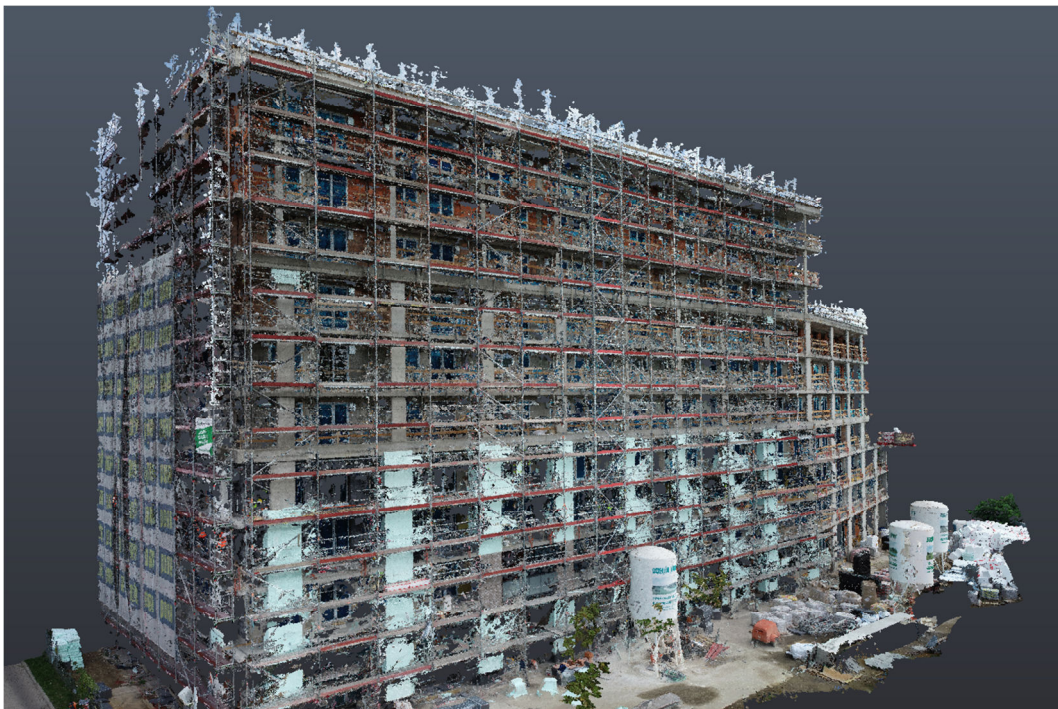
The photos taken during the raid, at a distance of approx. 10-15 m from the scaffolding, allowed for the development of a point cloud of the structure. To develop it, the photogrammetry technique was used, which allows obtaining a spatial representation of real objects based on photos [4] and Autodesk's ReCap software. The developed point cloud (Figure 6) is characterized by a high density of points (total number of points: 104,306,967), where each point is assigned coordinates in 3-dimensional space (X, Y, Z) and color (described with RGB coordinates).

6. General view of the developed point cloud
