**Investigation of the truss spans of railway bridge under operating load**

**Abstract:** The paper presents a description of the structure and its damage and a report on study under the operating load of three truss spans of 42.0 m length each. The spans are located in track no. 2 of two tracks railway Chorzów Batory – Tczew. They crosses the Warta River and its flood terrain in Działoszyn. Following spans are located along track no. 2: one steel beam span of 12.0 m, three truss spans of 42.0 m, one truss span of 32.0 m. The spans were built in 1941/42. They are rivet structures with parabolic shape and girders located under railway. A design of bridge repair and strengthening was prepared. Due to lack of funds the repair works were delayed, but all spans were in bad technical condition. Three the longest ones, which had been examined, had low lateral flexibility. Lateral vibration were noticed, which were consider to be dangerous with a speed limit on the bridge  $v \leq 100$  km/h and load class of  $k=+2$ ,  $\alpha_k=1,21$  (according to Polish code). The tests result forced the owner to start repair work immediately (mainly to install lateral stiffeners in all spans to elimi

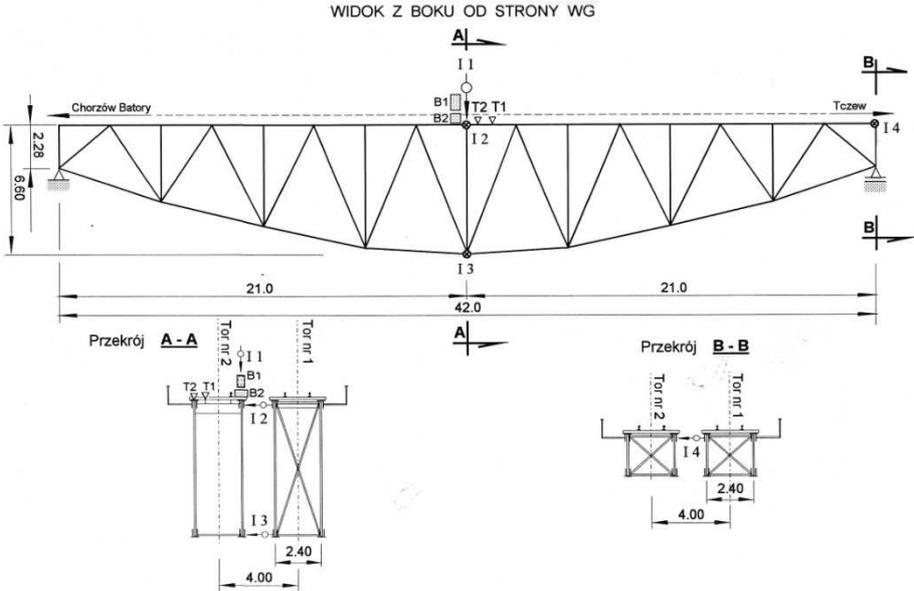
3. Location of measurement sensors on the bridge spans

In the case of span no. 3, only the measurement of unit deformations on the upper stripe in the half of the longitudinal span (T1) and on the upper stripe of the spar girder (T2) in the middle of its span was made. The location of the measurement sensors is shown schematically in Fig. 3. In the characteristic sections in the bays, No. 2 and 4, PDs-50 inductive sensors and OT-07 inertial sensors are placed side by side. At the same time, a continuous record was recorded from two inductive sensors and two inertia sensors and two strain gauges. Oscillograms of vibration velocity allow estimating the amplitude of dynamic displacements. On the basis of oscillograms of unit deformations, normal stress waveforms were determined at selected points of bearing elements of the bridge spans and extreme stress values. The reference point for the measurements of vertical and horizontal span displacements in the track No. 2 was the adjacent spans in the track No. 1, in the gap between train crossings. The research stand for each of the bays was located on the business pavement on the upper water side, at track No. 1. The load consisted of various combinations of locomotives, locomotives with wagons and draisines. For the purpose of this study, Fig. 4 presents the temporal waveforms of the measured oscillations. The analysis of the results suggests that horizontal (dynamic) vibrations are much greater than vertical vibrations. In tab. 1, dynamic coefficients calculated on the basis of measured extreme stress values, deflections and horizontal displacements in stringers and upper lattice girders were compiled and compared with dynamic coefficients calculated on the basis of the standard [4].
