Instytut Kolejnictwa

DOI: 10.35117/A\_ENG\_18\_05\_02

**Study of lateral wear of needles in railway switches**

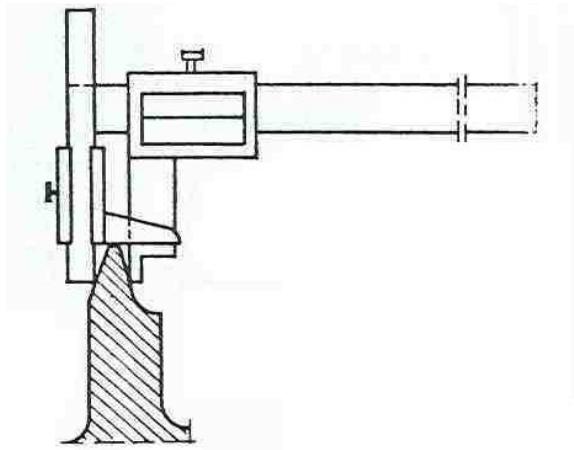
3. Measurement of the needle with a slide gauge

The lateral wear of the needles can be measured with a vernier caliper (figure 3) or an electronic profilometer (figure 4).
